MAS003187 (MSC 22-32)

Campaign 520

Service Campaign 520 MC20 – Engine Mount Metal/Rubber Adhesion Failure

DATE: JULY 29 2022

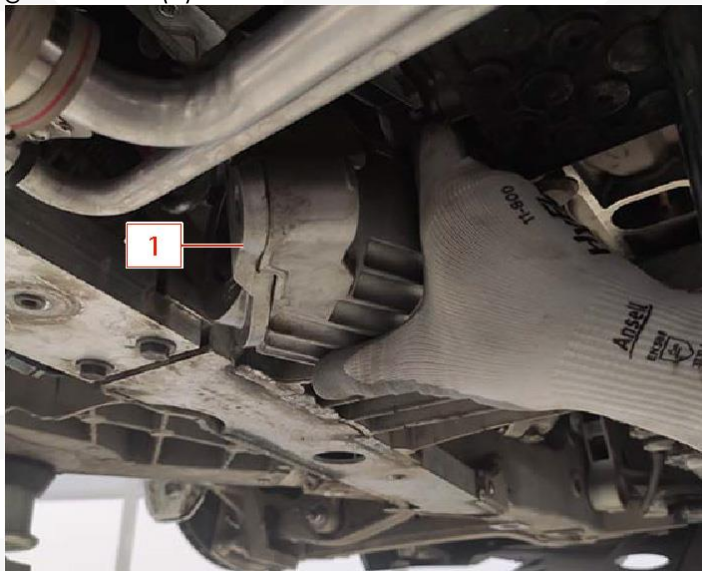
14. Remove the RH engine mount (1) as illustrated

16. Install new LH and RH engine mounts with new screws.
CAUTION: Be sure to hand start the screws to avoid cross-threading.

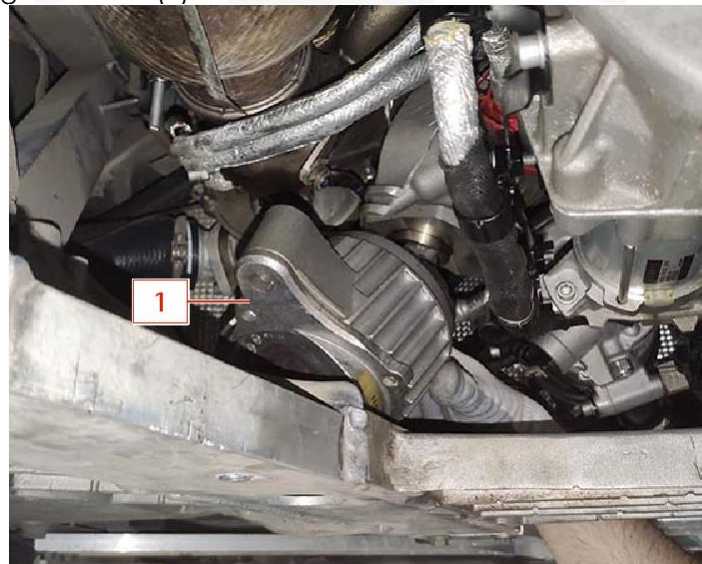
15. Remove the LH engine mount (1) as illustrated:
