Quality Bulletin

Service Action S10177: Apple CarPlay, Model Year 2021-2023 XC40, C40, XC60, S/V60, V60CC, V90, S90L, V90CC and XC90

GROUP: 39	CAT/NO: S10177	ISSUING DEPARTMENT: Safety and Compliance	CAR MARKET: United States and Canada	
REVISIONS:			ISSUE DATE: 2022-07-14	STATUS DATE: 2022-07-18
Page 1 of 4

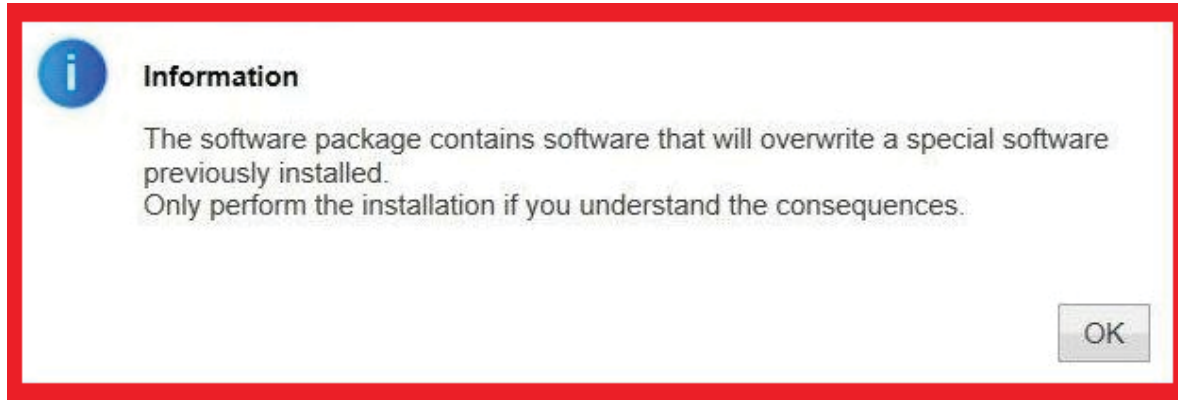
Please note: If the dialogue box below appears in VIDA stating, “The software package contains software that will overwrite a special software previously installed. Only perform the installation if you understand the consequences.” You are to reinstall Software according to TJ 36195 and claim accordingly.
