SIB 33 02 22

2022-07-28

SWINGARM DRAIN RETROFIT AND DRIVE SHAFT CHECK

**BMW
MOTORRAD****SERVICE ACTION – Swingarm Drain Retrofit and Driveshaft Check****MODEL**

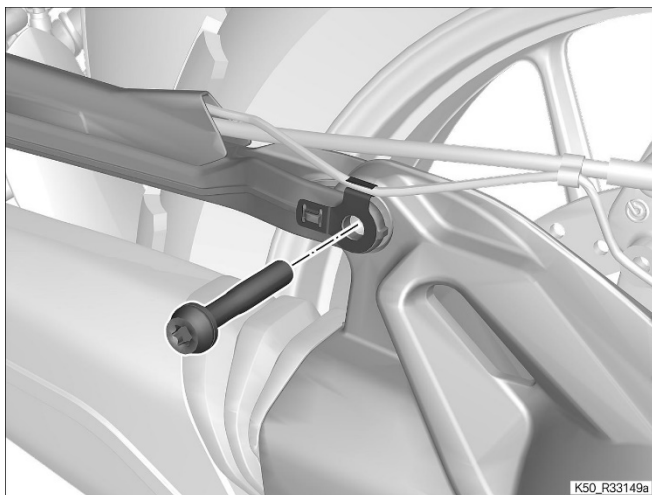
NOTICE: The bolting specification for the Paralever link on the rear axle has been changed. The relevant repair instructions in AIR have been updated.

Since the existing screw is being re-used, it is essential to clean the screw as well as the thread in the differential, and use **Loctite 2701** - PN 33 17 2 331 095 when re-installing.

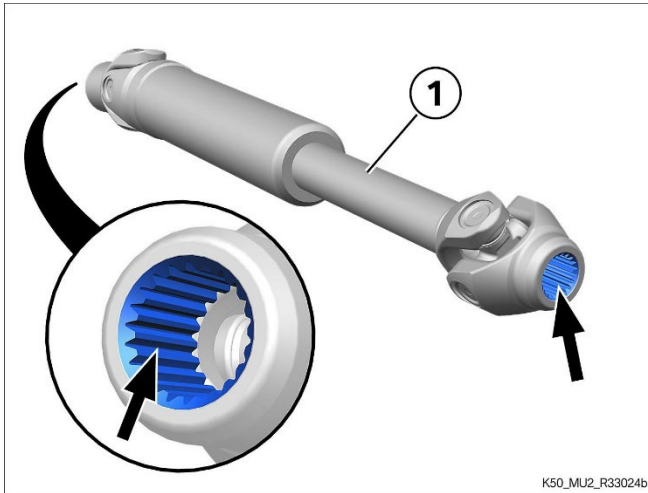
NOTICE: The workshop specification for the lubrication of splines of the driveshaft has been revised. The relevant repair instructions in AIR have been updated.

For replacement or re-greasing of the existing driveshaft, proceed as follows:

Carefully clean and lubricate gearing on driveshaft (1) with a wire brush, using Klüber lubricant LFT 71-402 – PN 83 23 8 847 417.

- Brush on lubricant with brush in recesses of gearing all the way around.
- Apply lubricating material over full length of gearing.

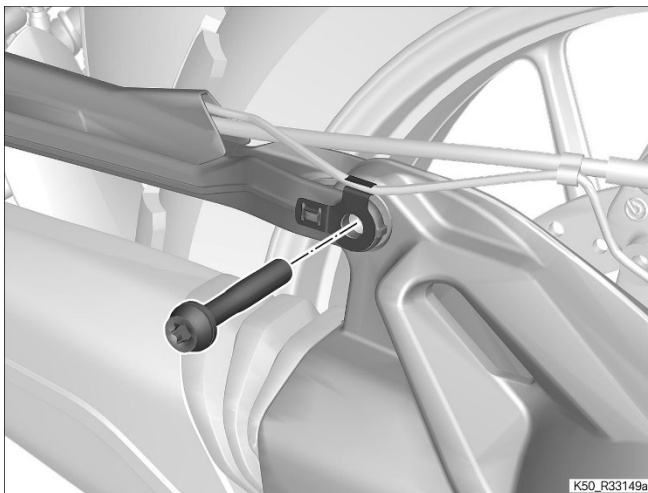
NOTICE: The bolting specification for the Paralever link on the rear axle has been changed. The relevant repair instructions in AIR have been updated.

Since the existing screw is being re-used, it is essential to clean the screw as well as the thread in the differential, and use **Loctite 2701** - PN 33 17 2 331 095 when re-installing.
