# Caulking retaining plate parking lock wheel NOK

**Division E / Plant: ZF Saarbruecken****Date:** [xx]**Status:** [xx]

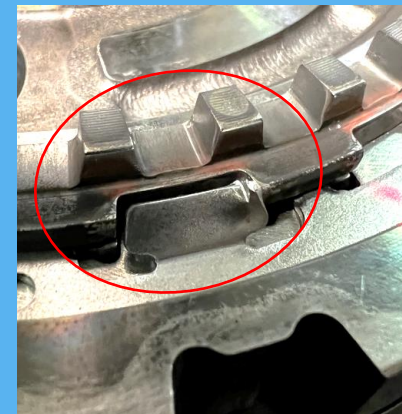
| Issue Description: | Caulking of the retaining plate for the parking lock wheel incorrectly performed; retaining plate not correctly crimped into position. Discovered during a standard SPC check. | | | | | | |

Example issue pattern

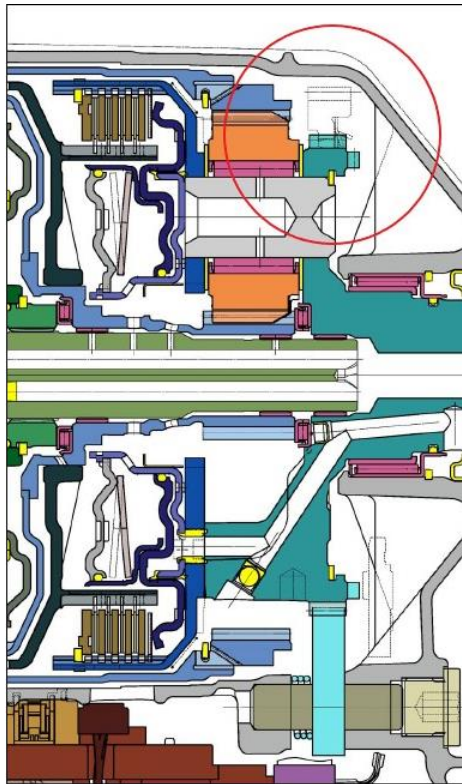
# Sectional drawing transmission 8HP75X

affected area "parking lock"

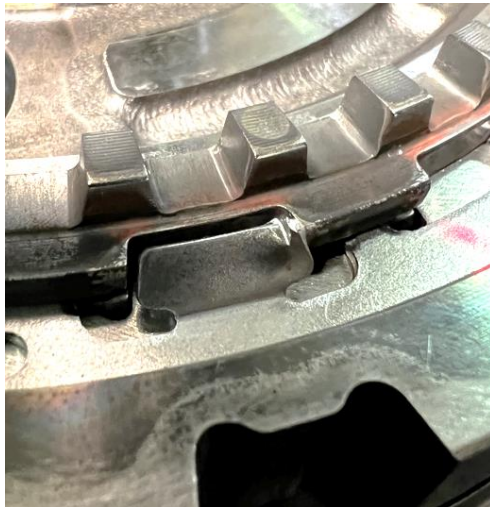
| Root Cause Analysis: | Issue in the crimping process (crimping machine)<br>The screw for the correct adjustment of the insertion angle (park lock wheel to retaining plate) had been torn off. This screw can be used to adjust the insertion angle in order to crimp the tabs of the retaining plate correctly positioned in the tooth space of the PSR. | | | | | | |

**NOK**

| Immediate Action: | <ul style="list-style-type: none"><li>Stop-Note at ZF</li><li>Repair the unit for adjustment, caulking station</li><li>Inspection interval increased (every 50 parts)</li></ul> | | | Q-Internal<br>Final Assembly<br>Final Assembly | 2022-05-04<br>2022-05-04<br>2022-05-04 | <input checked="" type="checkbox"/><br><input checked="" type="checkbox"/><br><input checked="" type="checkbox"/> | |

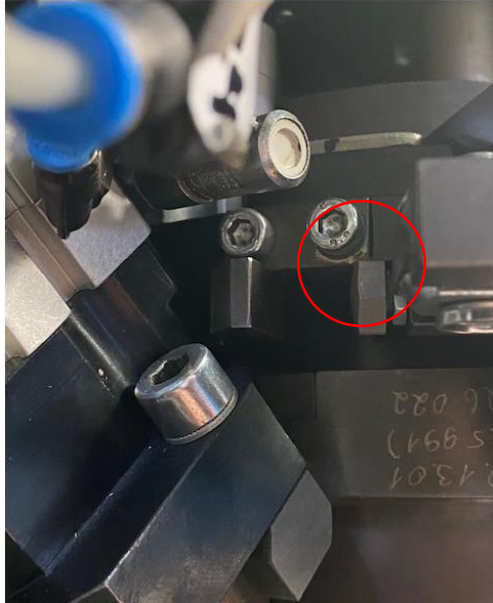
# Crimping process

Photo shows the crimping machine already after repair
