SIB 41 03 22

WATER INGRESS INTO VEHICLE DURING CAR WASH

E-Series	Model Description
G42	(2 Series Coupe)

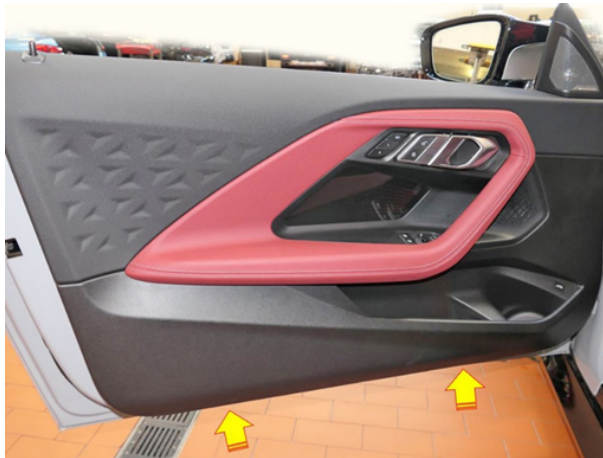
Due to high water pressure, water ingress is possible through the driver and/or passenger door. Water can penetrate through 2 small gaps between the door bottom and the side sill.

General location of the two gaps along the underside of the door shown (arrow). These can be viewed by looking up at the underside of the door.

Place protection foil on the depressed areas of both doors.

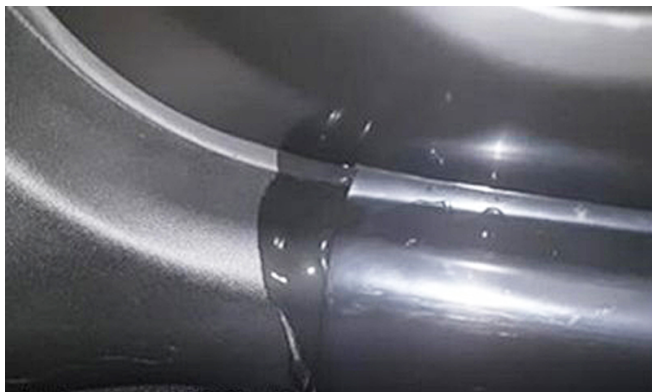
Close-up of one of the gaps.
