SIB 51 08 22

## WHISTLING NOISE FROM FRONT BUMPER

E-Series	Model Description
G20	(3 Series Sedan)

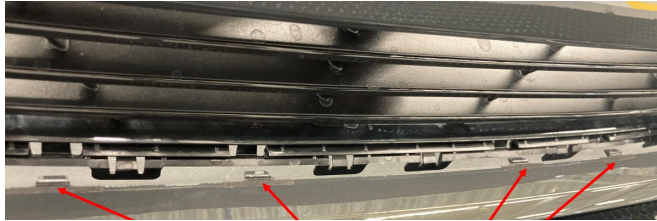
Whistling noise is heard coming from the front bumper while driving at highway speeds.

The noise is caused by the bottom clips of the lower grill. (As shown in the photo)

Place felt on the lower clips of the bumper.
