SIB 51 11 22

2022-06-21

DELIVERY STOP: REWORK THE RETAINING BRACKETS FOR THE SPINDLE DRIVE

E-Series	Model Description	Production Date
G01	X3 Sports Activity Vehicle (SAV)	May 17, 2022

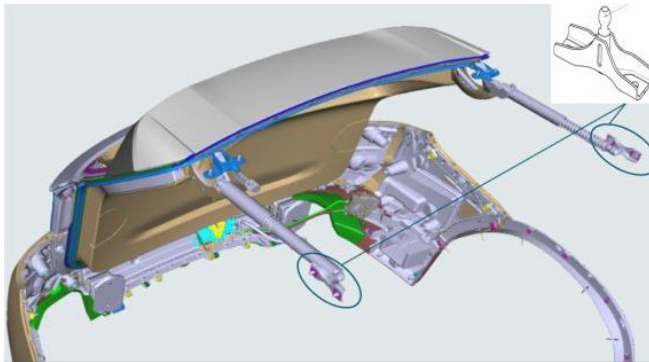
The bolts for the spindle drive retaining brackets were tightened to an incorrect torque.

Tighten the spindle drive retaining brackets to 28 Nm of torque.

Following repair instructions **51 24 351 "Removing and installing/replacing right electrical spindle drive for tailgate"** tighten the spindle drive retaining brackets to 28 Nm.
