SIB 51 13 18 LIN BUS FAULTS WITH EXTERIOR REARVIEW MIRROR GLASS DAMAGE

This Service Information Bulletin (Revision 7) replaces SI B51 13 18 dated February 2021.

E-Series	Model Description
F39	X2 Sports Activity Coupe
G20	3 Series Sedan
G29	Z4 Roadster

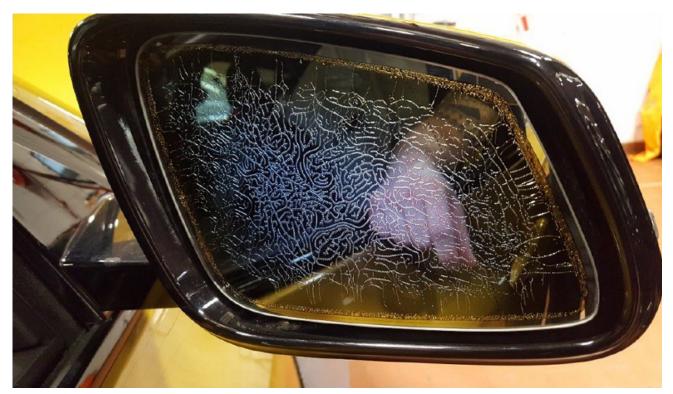
- A. The exterior rearview mirror glass is discolored or cracked
- B. The power windows and folding mirrors may not operate
- C. One or more of the following LIN bus faults are stored in the BDC (Body Domain Controller):

Faulty exterior rearview mirror electronics have created a short on the LIN bus, damaging the mirror glass and causing functional errors in power window and exterior mirror operation.

1. Test the operation of the power windows, side rearview mirror adjustment, and side rearview mirror folding functions. Inspect the side rearview mirror glass on both sides for damage as shown in the photo above.

Replace the mirror electronics in the exterior mirror.

3. Replace the mirror electronics of the affected mirror following repair instructions **REP 67 13 526** "**Replacing mirror electronics for electrically adjustable exterior mirror left or right**".

4. Replace the mirror glass, if damaged.
