SIB 61 10 22

SERVICE ACTION: REWORKING THE REAR POWER DISTRIBUTION BOX

This Service Information Bulletin (Revision 2) replaces SI B61 10 22 **dated May 2022**.

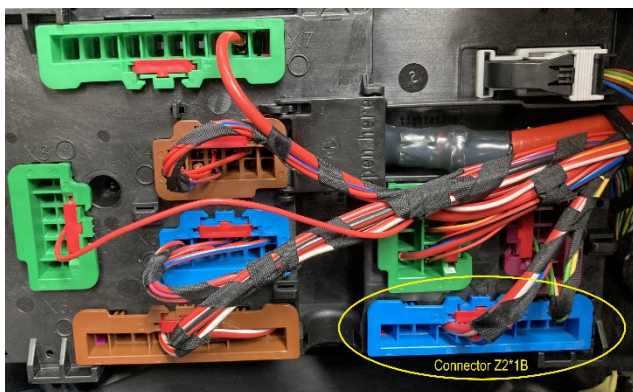
2. Locate and disconnect the blue connector (**Z2*1B**) from rear power distribution box.

1. Follow ISTA repair instructions “**61 14 010 Remove and install/replace power distribution box (trunk)**” to unlock and remove rear power distribution box from the holder.
