Dealer Principal	General Manager	Sales Manager	Service Manager	Parts Manager	Marketing	Finance
Date: June 15, 2022		Source:			Replaces: A 04 2022 04 U	
Bulletin #: A 06 2022 03 U		Name:			Supersedes: n/a	
		Title:			Group: n/a	
		Phone #:				
		Email:

Aftersales Bulletin

00 51 44 05 00 – Service Action Comfort Entry Access Deactivation

This Service Action affects Rolls-Royce Phantom (RR11/12), Ghost (RR21/22) and Cullinan (RR31), models produced from January 28th, 2022, to March 31st, 2022. The affected vehicles are fitted with Comfort Entry Access feature (option code 322).

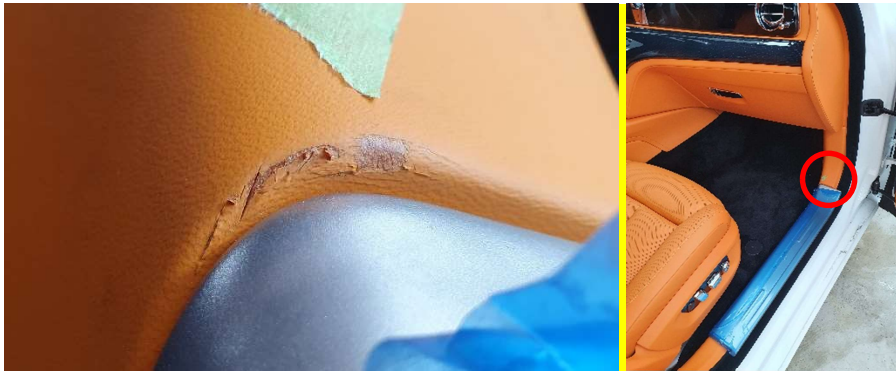
Risk of damage! Protect surfaces and pay extra care when working with high-quality interior materials.

1. Access the Body Domain Controller by removing the front right A-pillar side panel, please refer to REP: 51 43 075 Remove and install side trim panel, footwell, on A-pillar right .

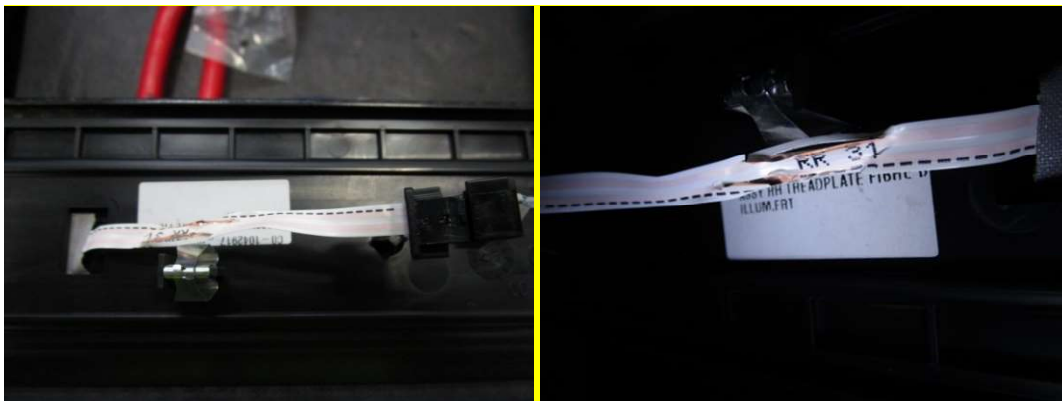
Risk of damage! Pay extra care when fitting Illuminated Treadplates to ensure that the wire/ribbon does not become damaged.
