SIB 51 05 22 DELIVERY STOP: TORSION STRUTS

2022-07-12

This Service Information Bulletin (Revision 3) replaces SI B51 05 22 **dated May 2022**.

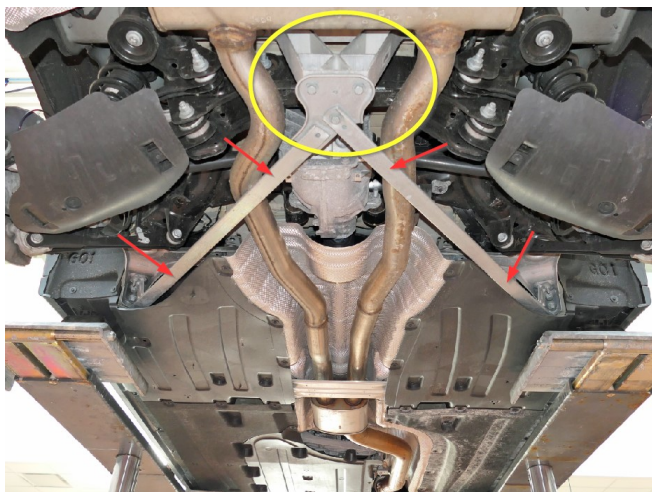
1. Inspect the vehicle underbody for the presence of the torsion struts (circles/arrows below). If the torsion struts are not installed, continue to step 2. Otherwise, no additional correction is necessary.

Note: The tightening torque for the mounting block to the body (component in the yellow circle above) is 56 Nm.

Caution: On plug-in hybrid vehicles, the mounting block is always installed at the factory. Only the torsion struts have to be retrofitted here if not installed.

2. Install the torsion struts. Repair instructions can be found within ISTA REP 18 00 018 **"Remove and install complete exhaust system"**.
