SIB 51 09 22

## SQUEAKING NOISE FROM DRIVER EXTERIOR MIRROR WHEN FOLDING IN AND OUT

| E-Series | Model Description | Production Date | Affected Option Code |
|---|---|---|---|
| G26 | 4 Series Gran Coupe | From Start of Production (7/2021) thru approx. 5/2022 | All |

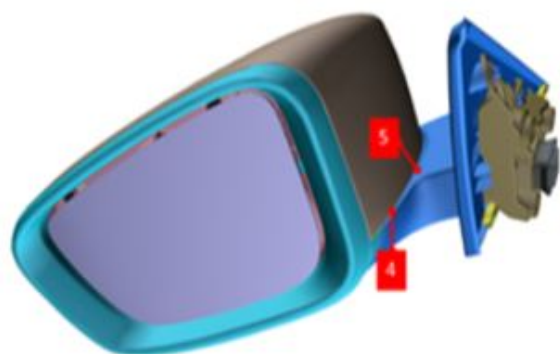
The gap (4 & 5) between the base and cap of the exterior mirror is too small due to manufacturing oversight.

This tight gap only applies to the driver’s side mirror, because the passenger mirror was produced with different tooling.

Replace the driver’s exterior mirror assembly.

- The painted mirror cap will be reused from the original mirror
