SIB 61 13 22

2022-07-20

DELIVERY STOP: REPLACE "SMART OPENER" CONTROL UNIT

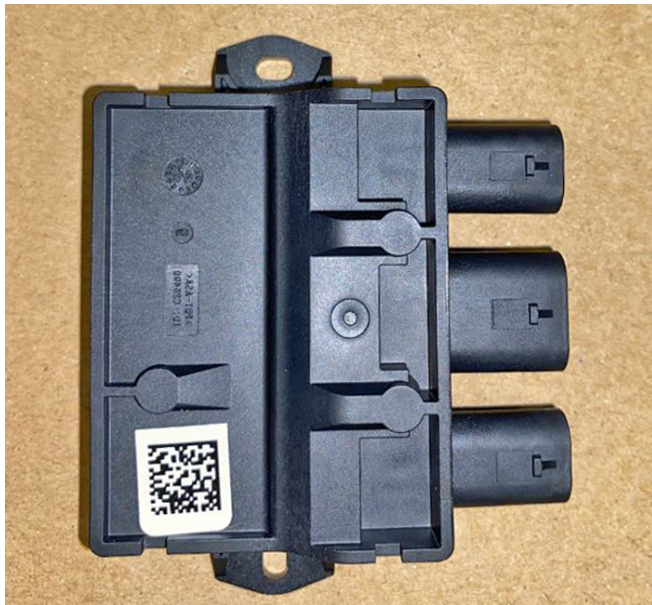
2. Remove and discard the "non-functional" smart opener control unit which acted as a circuit "jumper".

The jumper unit was factory-installed to enable other Comfort Access systems to be utilized during the vehicle transport process.

Note that the jumper unit closely resembles the replacement part- Do not mix them up!

Discard the factory-installed jumper unit.

3. Install the functional smart opener control unit P/N 61 35 5A3F3E8 or P/N 61 35 5A562D6. Both P/N are interchangeable.
4. Perform a sleep cycle until the hazard warning switch light goes out, which can take up to 30 minutes.
5. Wake the vehicle and check the functionality of Contact-free trunk lid/tailgate opening.
