# TECHNICAL SERVICE BULLETIN

## 400 Watt DC/AC Inverter System Inoperative With B1330:9A In The BCM

22-2324

**Ford**  
2021-2022 F-150

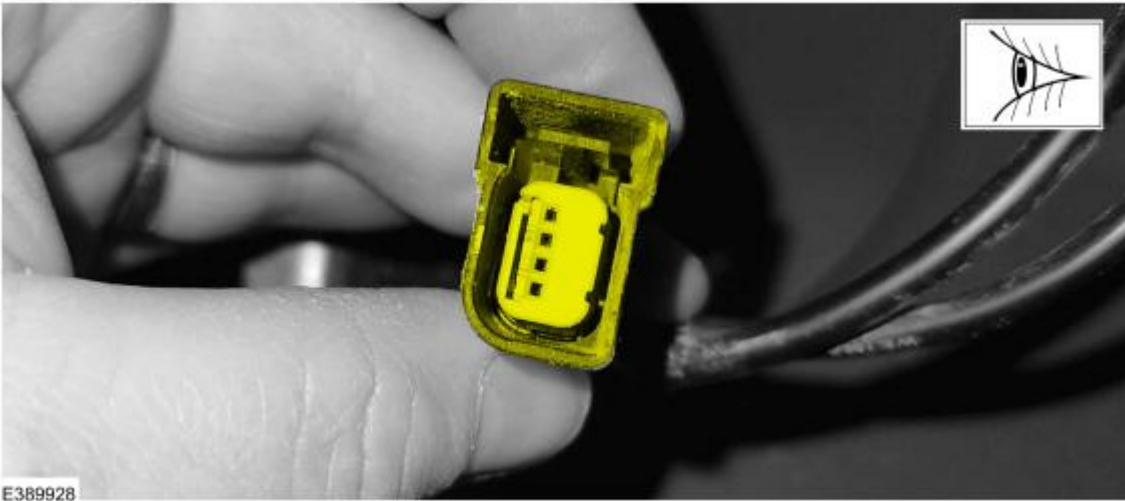
Figure 2

2. Using a suitable tool, carefully cut and remove the pickup bed AC power outlet socket harness retainer from the pickup bed AC power outlet socket harness. Discard the retainer.
3. Inspect connector C4628 for the presence of corrosion, dirt and/or damage. Is corrosion, dirt and/or damage present in connector C4628? (Figure 2)

(1). Yes - replace the pickup bed AC power outlet socket assembly. Refer to Workshop Manual (WSM), Section 414-05. Replace the body side harness assembly (13A409) of connector C4628. Proceed to Step 4.

(2). No - proceed to Step 4.

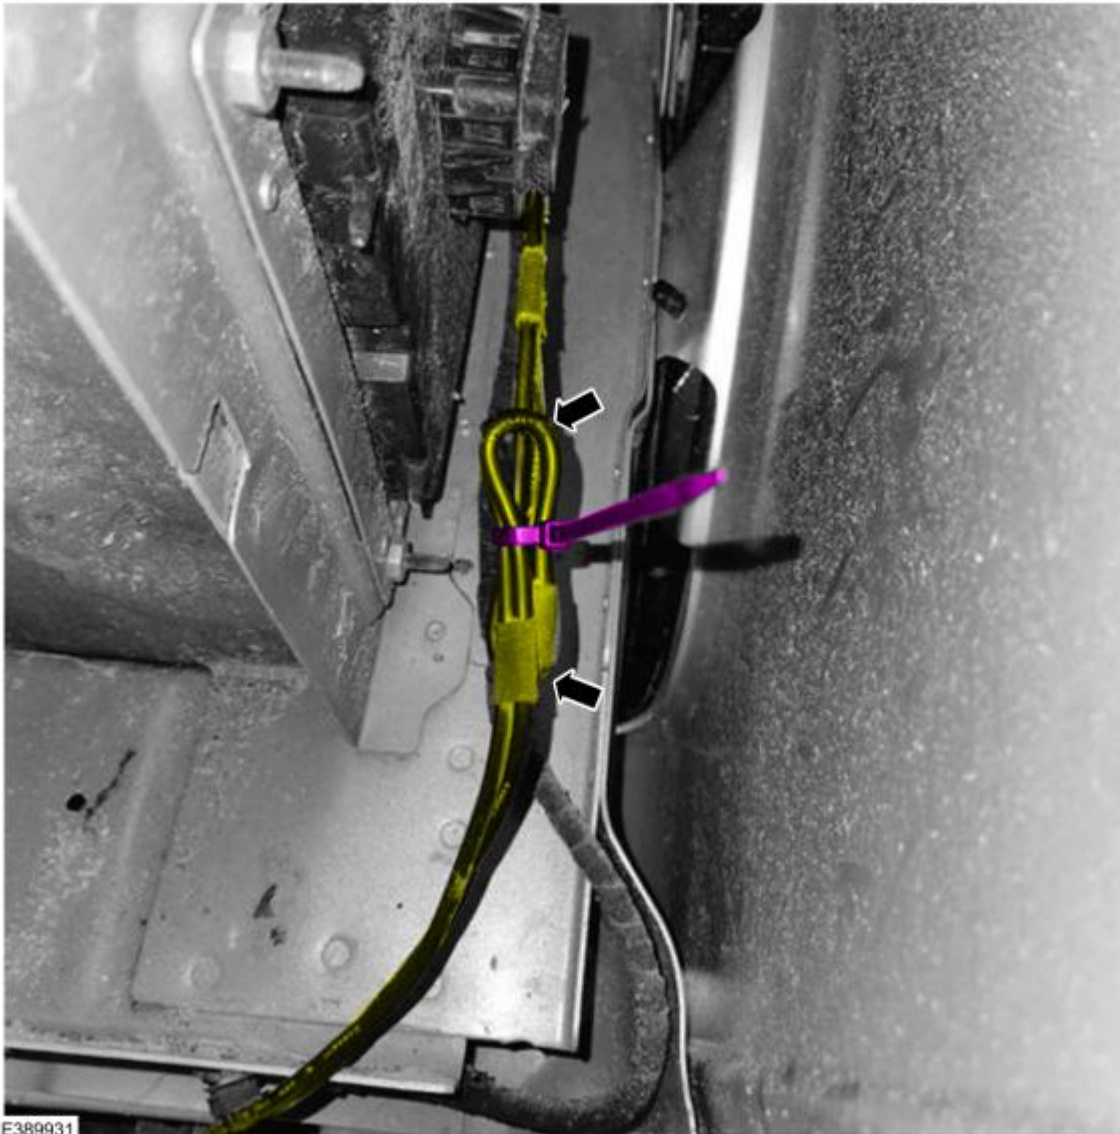
Figure 5

**⚠ CAUTION: The bend radius of the pickup bed AC power outlet socket harness should be no less than 4 mm. Hard kinks and tight bends of the pickup bed AC power outlet socket harness can lead to wire damage.**

6. Fold approximately 7 in. (185 mm) of the remaining/loose pickup bed AC power outlet socket harness in 2 bends just behind the pickup bed AC power outlet socket panel. Secure the folded wire with a wire tie. Inspect the routing of the harness to make sure it is not pulled too tight against the body sheet metal near the harness retainer and provides just enough length. (Figure 5)
