TECHNICAL SERVICE BULLETIN

Tailgate Snap, Click, And/Or Pop Noise When Closing

22-2327
17 August 2022

Ford 2021-2022 F-150

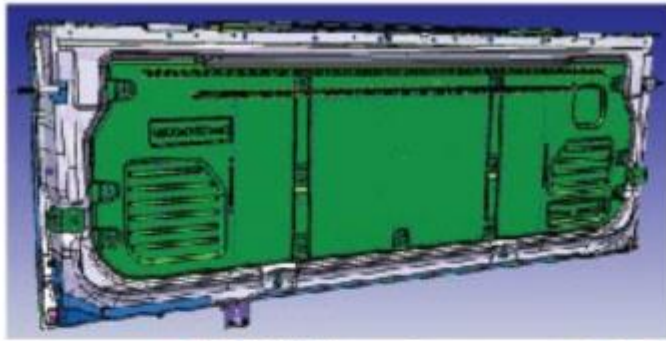
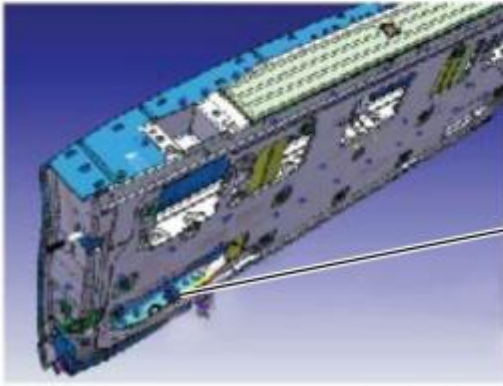
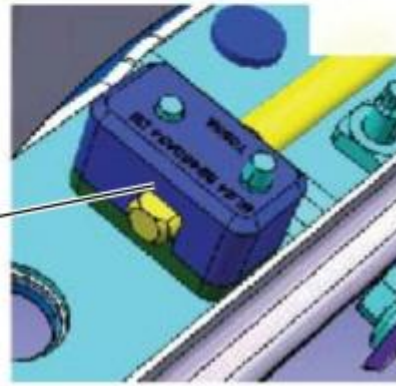
Figure 1

1. Remove the tailgate. Refer to Workshop Manual (WSM), Section 501-04 > Pickup Bed and Platform Body.
2. Remove the tailgate panel. Refer to WSM, Section 501-04 Pickup Bed and Platform Body > Power Tailgate Motor > Step 2.
3. If equipped, reposition the power tailgate motor to gain visual access to the torsion rod and clamp block. Refer to WSM, Section 501-04 Pickup Bed and Platform Body > Power Tailgate Motor.
4. Visually inspect the tailgate torsion rod and clamp block interface. (Figure 1) Is there a gap between the blocks? (Figure 2)

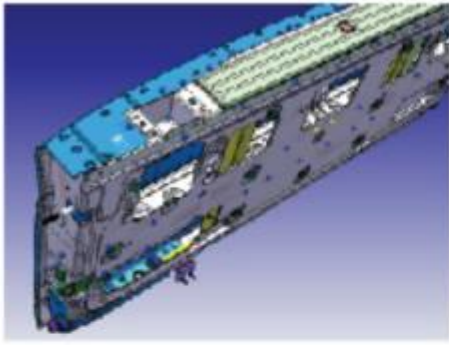
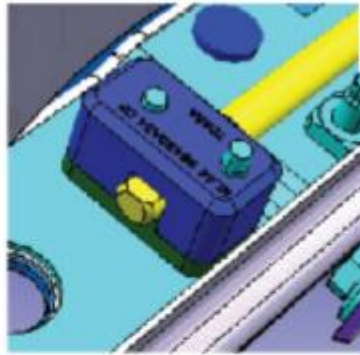
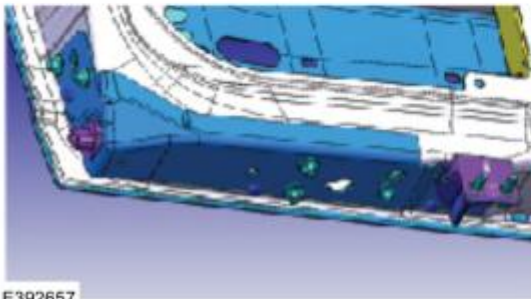
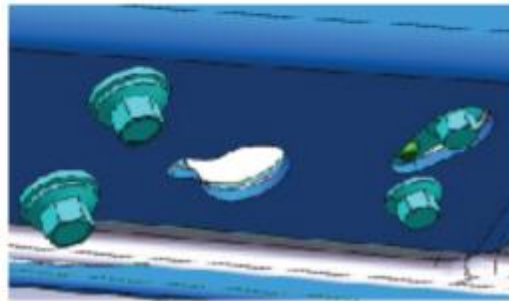
Figure 3

5. Verify the tailgate torsion rod is correctly aligned in the clamp block and the bolts are properly tightened. (Figure 3)

- (1). Loosen or remove the shorter bolt.
- (2). Loosen the longer bolt 1-2 rotations (as little as possible) to allow the tailgate torsion rod to rotate.
- (3). Rotate the tailgate torsion rod to verify the machine flat on the rod properly aligns with the top block (flat) mating surface. (Figure 4)
