TECHNICAL SERVICE BULLETIN

Classification: BT22-001A	Reference: NTB22-019A	Date: July 20, 2022
------------------------------	--------------------------	------------------------

RATTLE NOISE FROM INSTRUMENT PANEL AREA AT IDLE AND/OR ON ACCELERATION

APPLIED VEHICLES: 2021 Rogue (T33)
APPLIED VINS: 11th character of VIN is C

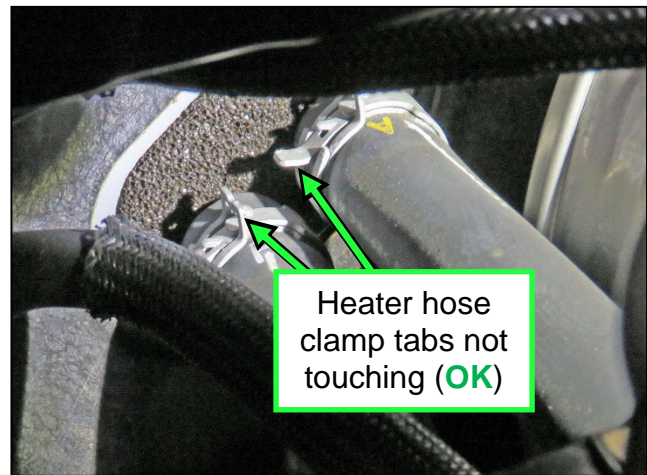
Figure 1

- If the tabs on the heater hose clamps are not touching each other, continue to step 3.

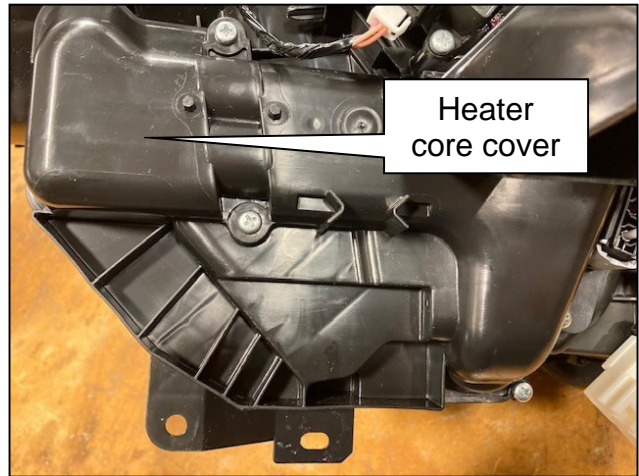
Figure 4

4. Lightly press on the heater core cover while duplicating the conditions needed for the rattle to occur.
 - If the rattle is not present when lightly pressing on the heater core cover, continue to step 5.
 - If the rattle is still present when lightly pressing on the heater core cover, this bulletin does not apply. Refer to the ESM for further diagnostic and repair information.

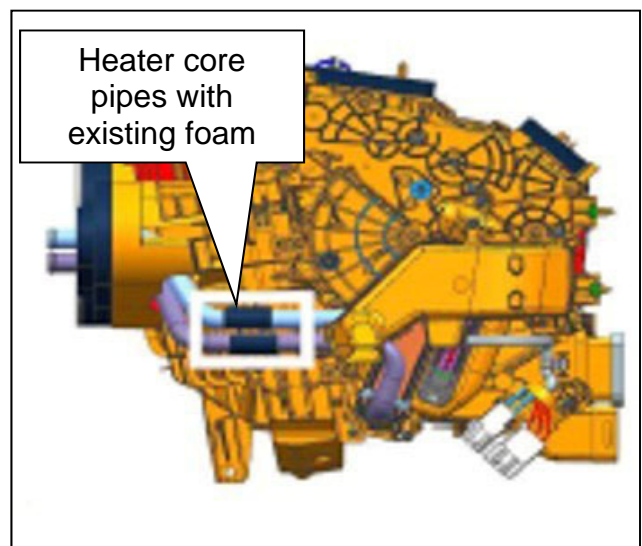
Figure 6

HINT: Some foam may already be present on the heater core pipes (Figure 6).
