HYUNDAI
Technical Service Bulletin

GROUP CAMPAIGN	NUMBER 22-01-066H
DATE AUGUST 2022	MODEL(S) VELOSTER N (JSN)

SUBJECT: CONCENTRIC SLAVE CYLINDER (CSC) FASTENING BOLT TORQUE CHECK AND TIGHTENING (SERVICE CAMPAIGN T8U)

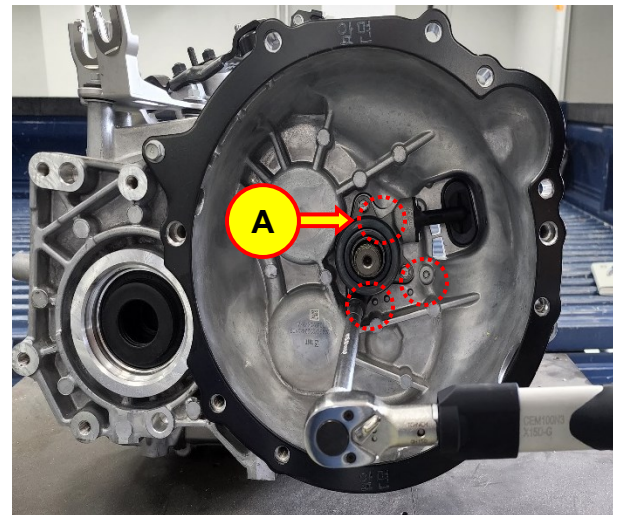
2. Check the fastening torque value of the concentric slave cylinder (CSC) assembly mounting bolts (A).

- 1) If the fastening torque value of the 3 bolts (A) is normal, continue to Step #3 and finish the operation.
- 2) If the fastening torque is not met, proceed with the operation according to the fastening torque value.

Tightening Torque:

11.8 ~ 14.7 Nm (1.2~ 1.5 kgf.m, 8.7 ~ 10.8 lb-ft)
