# TECHNICAL SERVICE BULLETIN

Classification: AN22-016	Reference: NTB22-055	Date: July 7, 2022
-----------------------------	-------------------------	-----------------------

## SOFTWARE UPDATE FOR INFOTAINMENT ISSUES

**APPLIED VEHICLES:** 2021-2022 Maxima (A36)

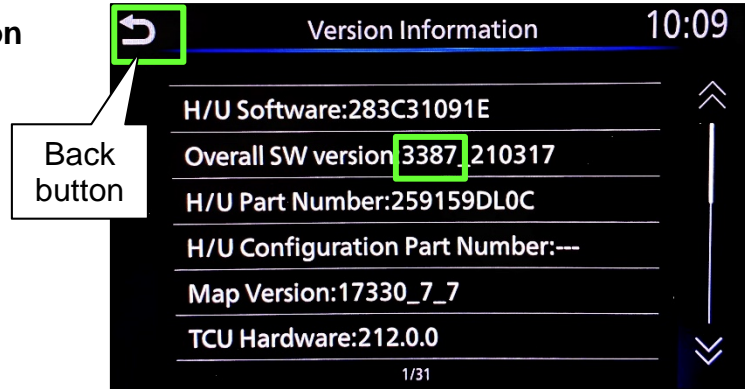
Figure 5

4. Confirm if the **Overall SW version** begins with "3387".

- If the **Overall SW version** begins with "3387", select the back button; this bulletin does not apply, skip to **CLAIMS INFORMATION** on the last page.
- If the **Overall SW version** does NOT begin with "3387", select the back button and then continue to step 5 on page 5.

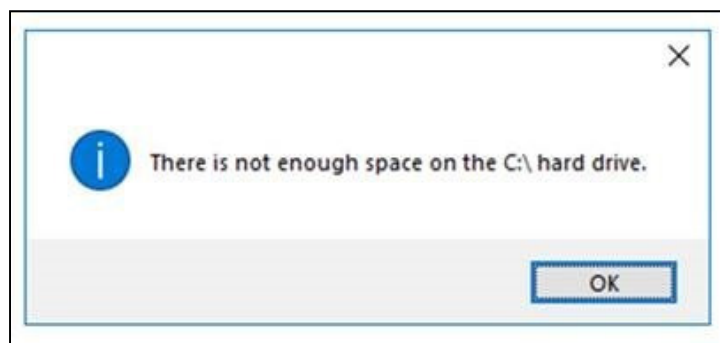
Figure 8

- The update-software is estimated to take 4 hours to download to the USB drive.
- If, while attempting to download the software to the CONSULT PC, you receive the message shown in Figure 8:
  - Attempt to clear space on the CONSULT PC hard drive.

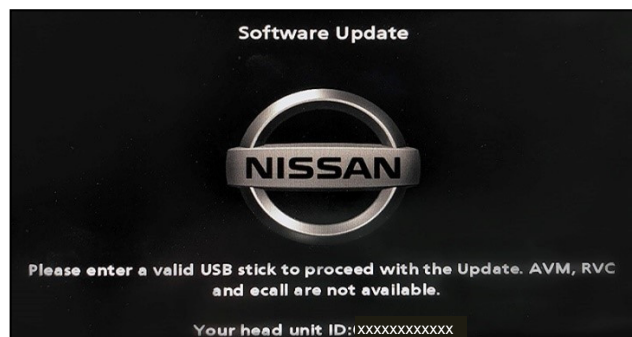
- The screen in Figure 13 may briefly appear. **Do not remove the USB drive.** The audio system will detect the USB drive and continue the update.
