HYUNDAI Technical Service Bulletin	GROUP CAMPAIGN	NUMBER 22-01-068H
	DATE AUGUST, 2022	MODEL(S) PALISADE (LX2)
SUBJECT: DDM (DRIVER DOOR MODULE) SOFTWARE UPDATE (SERVICE CAMPAIGN T8S)

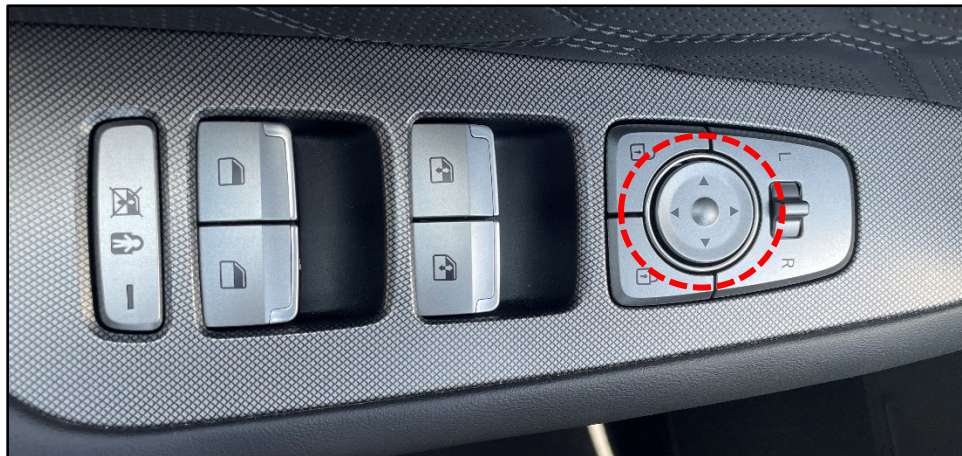
Description: Some 2022 Palisade (LX2) vehicles may experience an intermittent inoperative adjustment function of the driver and passenger outside mirrors. The driver intermittently cannot adjust the outside mirrors.

This bulletin provides the service procedure to update the DDM (Driver Door Module) or DAU (Driver Door Area Unit) software to resolve the condition stated above.

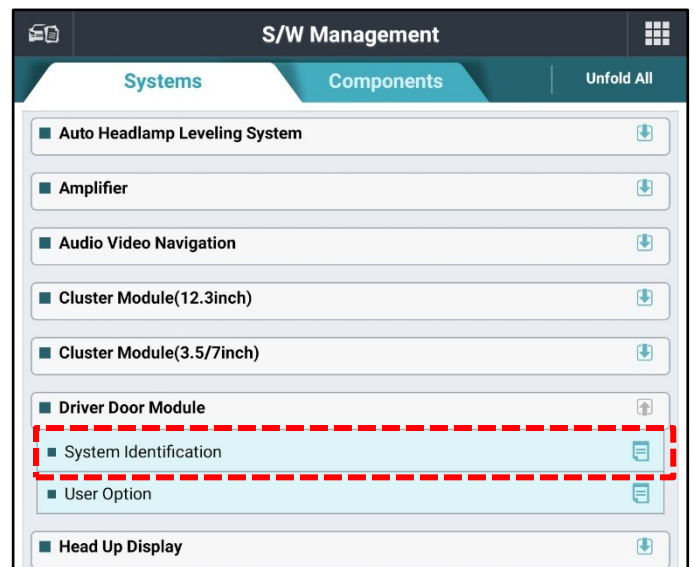
In the example to the right the ROM ID version is 104/20191107.

If the DDM software does not require an update, then procedure is complete. Submit op code 20D084R2.

If the DDM software requires an update, then proceed with updating the software.
