# VOLUNTARY SERVICE CAMPAIGN

Classification: AT22-006	Reference: NTB22-057	Date: July 14, 2022
-----------------------------	-------------------------	------------------------

## VOLUNTARY EMISSION SERVICE CAMPAIGN 2021 ROGUE; ENGINE CONTROL MODULE, TRANSMISSION CONTROL MODULE, AND SHIFT CONTROL MODULE REPROGRAM

**CAMPAIGN ID #:** P2A07  
**APPLIED VEHICLES:** 2021 Rogue (T33)

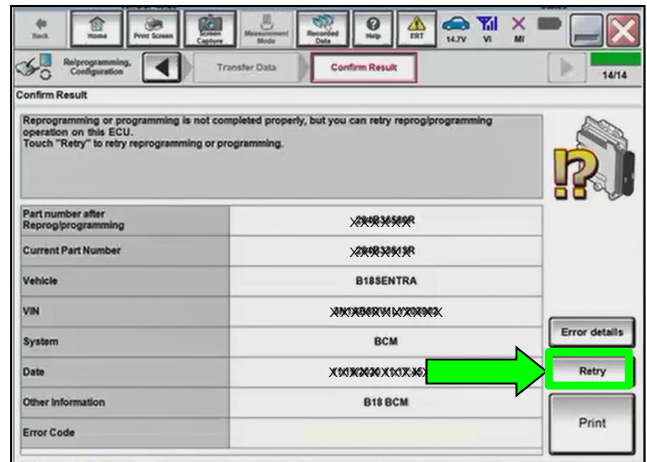
Figure 16

If reprogramming does not complete and the “!” symbol displays as shown in Figure 16:

- Check battery voltage (12.0 – 15.5V).
- Ignition is ON, Engine is OFF.
- External Bluetooth® devices are OFF.
- All electrical loads are OFF.
- Select **Retry** and follow the on screen instructions.

**NOTE:** **Retry** may not go through on first attempt and can be selected more than once.

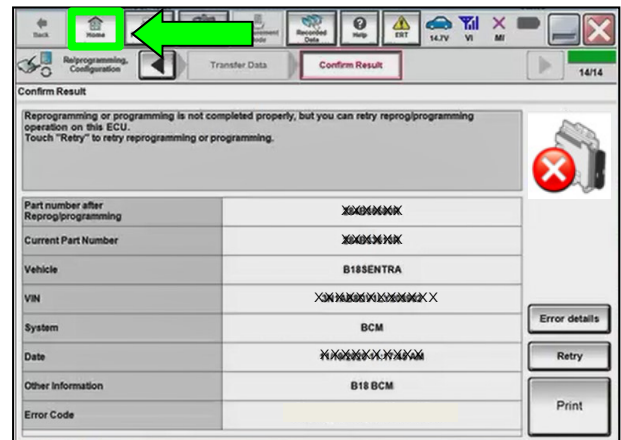
Figure 17

If reprogramming does not complete and the “X” symbol displays as shown in Figure 17:

- Do not disconnect the VI or shut down C-III plus if reprogramming does not complete.
- Check battery voltage (12.0 – 15.5V).
- CONSULT A/C adapter is plugged in.
- Ignition is ON, Engine is OFF.
- Transmission in Park.
- All C-III plus / VI cables are securely connected.
- All C-III plus updates are installed.
- Select **Home**, and then restart the reprogram procedure from the beginning.
