TECHNICAL SERVICE BULLETIN

Classification: AN22-019	Reference: NTB22-058	Date: July 20, 2022
-----------------------------	-------------------------	------------------------

SOFTWARE UPDATE FOR INFOTAINMENT ISSUES

APPLIED VEHICLES: 2020-2022 LEAF (ZE1)

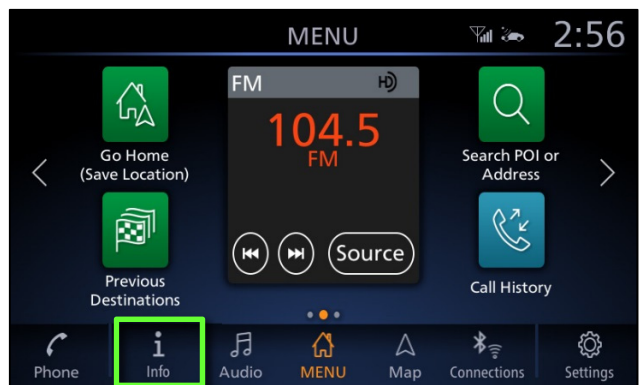
Figure 3

- If the **Info** icon does not appear, as shown in Figure 3, this bulletin does not apply.

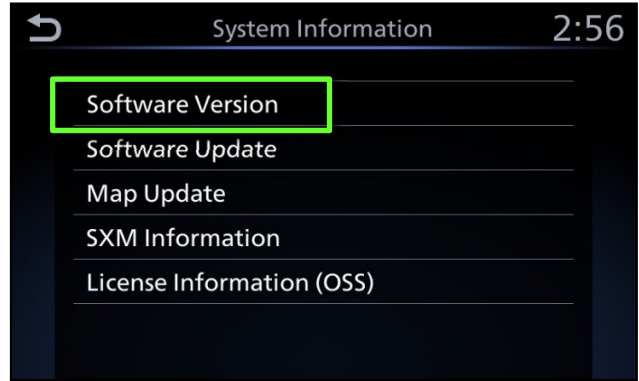
Figure 5

- If the **Software Version** is "344", "345" or "347", select the back icon and continue to step 5 on page 5.
- If the **Software Version** is "354", the infotainment system already has the latest version. Select the back icon, and then proceed to the **CLAIMS INFORMATION**.

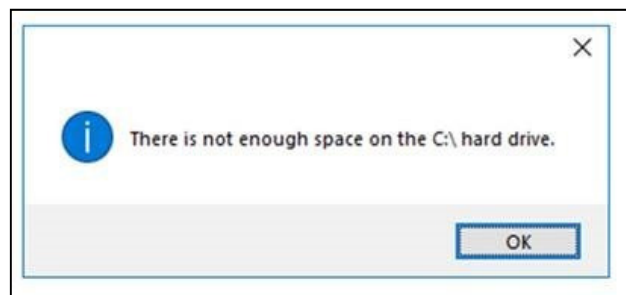
Figure 9

- The update-software is estimated to take **4 hours** to download to the USB drive.
- If, while attempting to download the software to the CONSULT PC, you receive the message shown in Figure 9:
 - Attempt to clear space on the CONSULT PC hard drive.
