# TECHNICAL SERVICE BULLETIN

Classification: EC22-007	Reference: NTB22-066	Date: July 29, 2022
-----------------------------	-------------------------	------------------------

## DTC P2DFD STORED IN THE ECM

**APPLIED VEHICLES:** 2022 Rogue (T33)

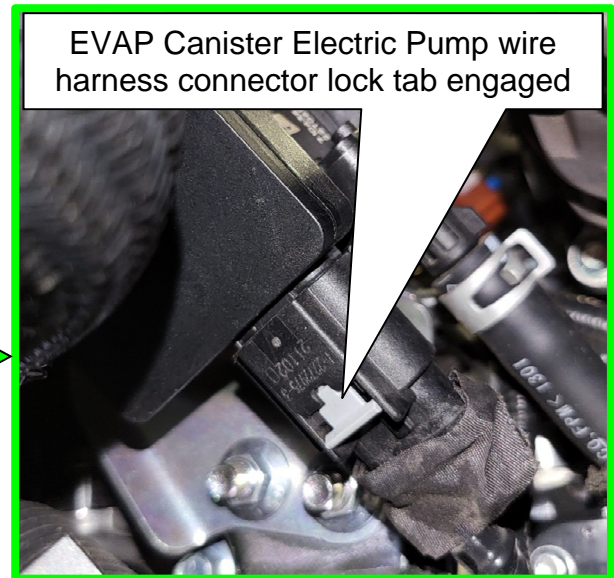
Figure 2

If you confirm DTC P2DFD (PURGE PUMP PERFORMANCE) is stored in the ECM,

1. Turn the ignition OFF.
2. Disconnect the EVAP Canister Electric Pump wire harness connector (Figure 2).
3. Re-connect the EVAP Canister Electric Pump wire harness connector and then verify the wire harness connector is fully seated, connected, and the wire harness connector lock tab is engaged (Figure 2).
