Service Campaign

2021-2023MY
Seltos (SP2) AWD
w/2.0L MPI engine

SC242

TRANSFER CASE LEAKAGE/OVERHEATING
WHEN USING SPARE TIRE (SC242)

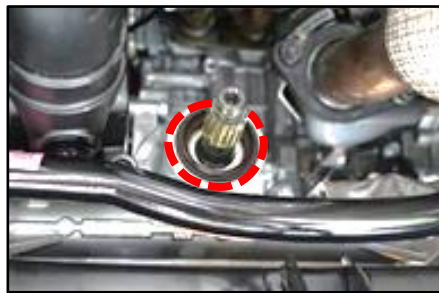
Front Wheel Transfer Assembly Oil Seal

This bulletin provides the procedure to inspect the front wheel transfer assembly for oil leakage and update the 4-Wheel Drive (4WD) (also referred to as All-Wheel Drive [AWD]), coupling operation logic software on certain 2021-2023MY Seltos (SP2) AWD vehicles equipped with Nu 2.0L MPI engine, produced from November 20, 2019 through May 18, 2022. Some of these vehicles may exhibit a front wheel transfer assembly oil seal leak, oil burning smell, and possible smoke due to the transfer case overheating when using the spare tire. This may be caused by AWD ECU software detection logic not detecting the installed spare tire, which would normally limit transfer case usage/operation. If the spare tire is in use and not detected, transfer case oil temperatures can rise, and a burning oil smell can be detected. Follow the procedure outlined in this publication as follows:

- If oil leak is present (NG), replace the oil seal and upgrade the AWD coupling logic software.
- If oil leak is not present (OK), upgrade the AWD coupling logic software.

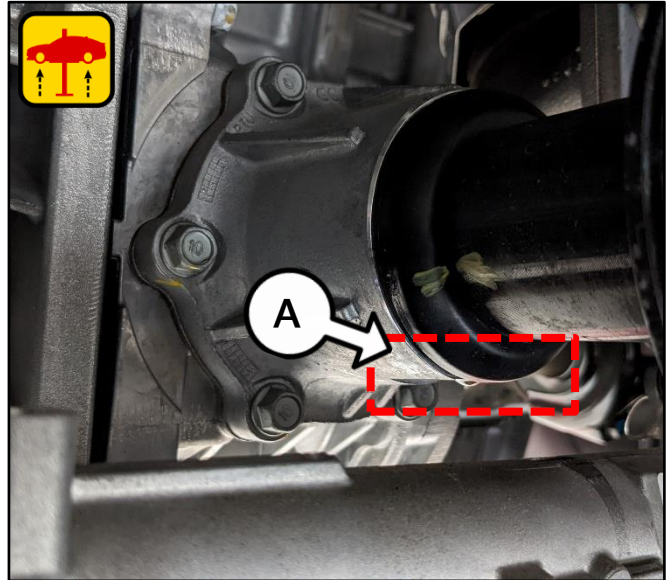
1. Raise vehicle on lift.
2. Inspect the front wheel transfer assembly output seal area (A) for oil leakage in the area shown.

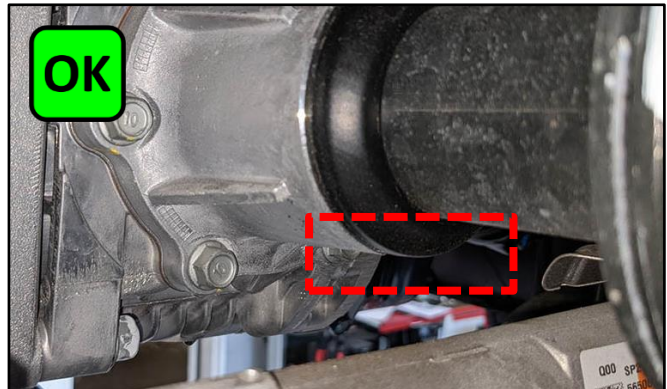
- If oil leak is **not** present (OK), proceed to the 'ECU Upgrade Procedure' on page 4 to complete this service action.

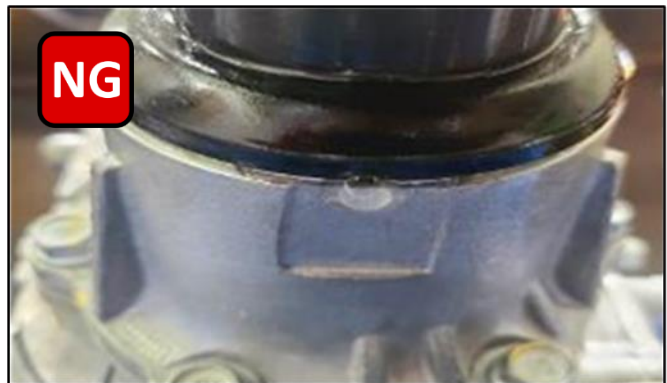
- If oil leak is **present** (NG), proceed to the 'Replacement Procedure' on page 3 to replace the front wheel transfer assembly oil seal.
