Technical Service Bulletin

10 Oil is lost from the filler cap

10 22 24 2059446/5 August 23, 2022. Supersedes Technical Service Bulletin Group 10 number 21-21 dated March 8, 2021, for reasons listed below.

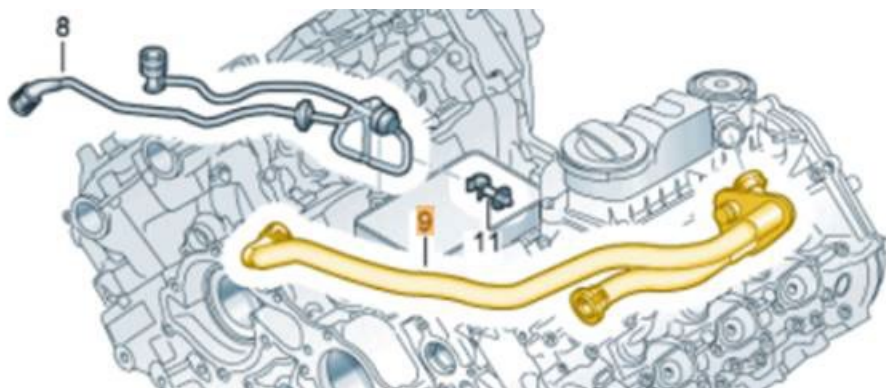
A faulty membrane in the breather line can result in excess pressure in the crankcase and therefore some oil is lost through the filler cap.

Figure 1. Breather line for the Turbocharged V6.

Replace the breather line (different variants available, only order by VIN) by following the Elsa repair manual (Figures 1 and 2).

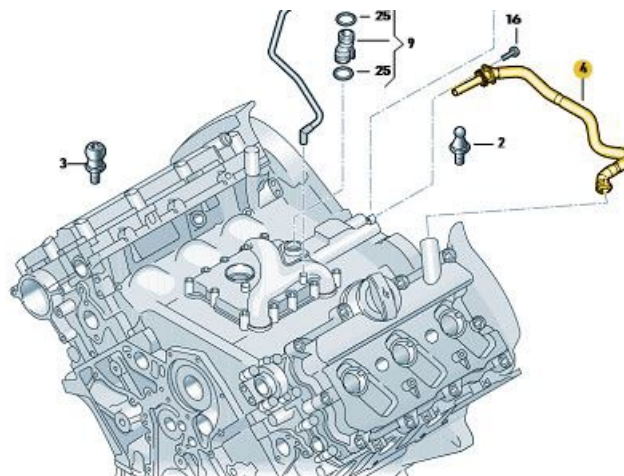
Figure 2. Breather line for the Supercharged V6 (EVO).
