INFINITI

TECHNICAL SERVICE BULLETIN

Classification: AN21-023A	Reference: ITB21-026A	Date: June 21, 2022
------------------------------	--------------------------	------------------------

SOFTWARE UPDATE FOR CLOCK INCORRECT

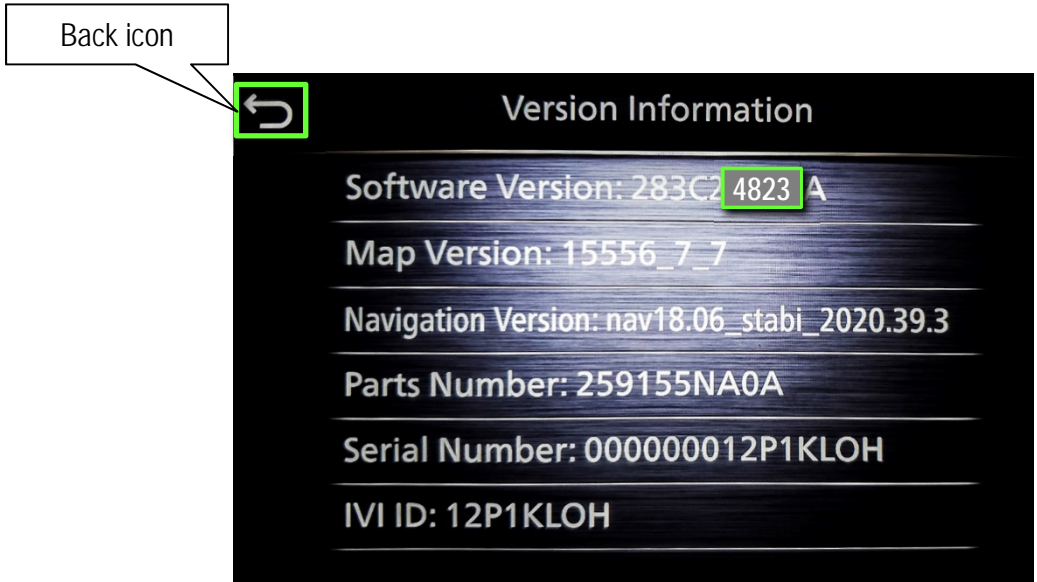
Figure 5

- If the Software Version (refer to digits 6-9, as shown in Figure 5) is **lower** than xxxxx**4823**x, select the back icon and continue to step 5 on the next page.
- If the Software Version (digits 6-9) is xxxxx**4823**x or higher, this bulletin does not apply. Select the back icon and refer to ASIST for further diagnostic information.
