TECHNICAL SERVICE BULLETIN

Classification:	Reference:	Date:
TF16-001E	NTB17-003E	June 17, 2022

FLUID LEAK CAUSED BY TRANSFER ASSEMBLY RIGHT SIDE DRIVE SHAFT OIL SEAL

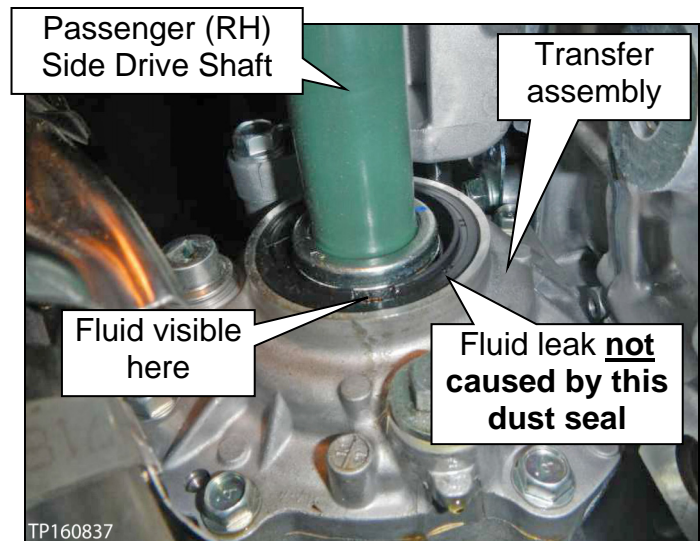
Figure 1

If fluid is leaking from the front passenger (RH) side of the transfer assembly, refer to the information in this bulletin.

- The fluid leak is **NOT** caused by the dust seal shown in Figure 1.
- This repair does **NOT** require transfer assembly removal from the vehicle.

1. DO NOT REPLACE the transfer assembly.
2. Replace the drive shaft oil seal and the dust seal.
 - Refer to NTB21-094 for drive shaft oil seal and dust seal replacement.

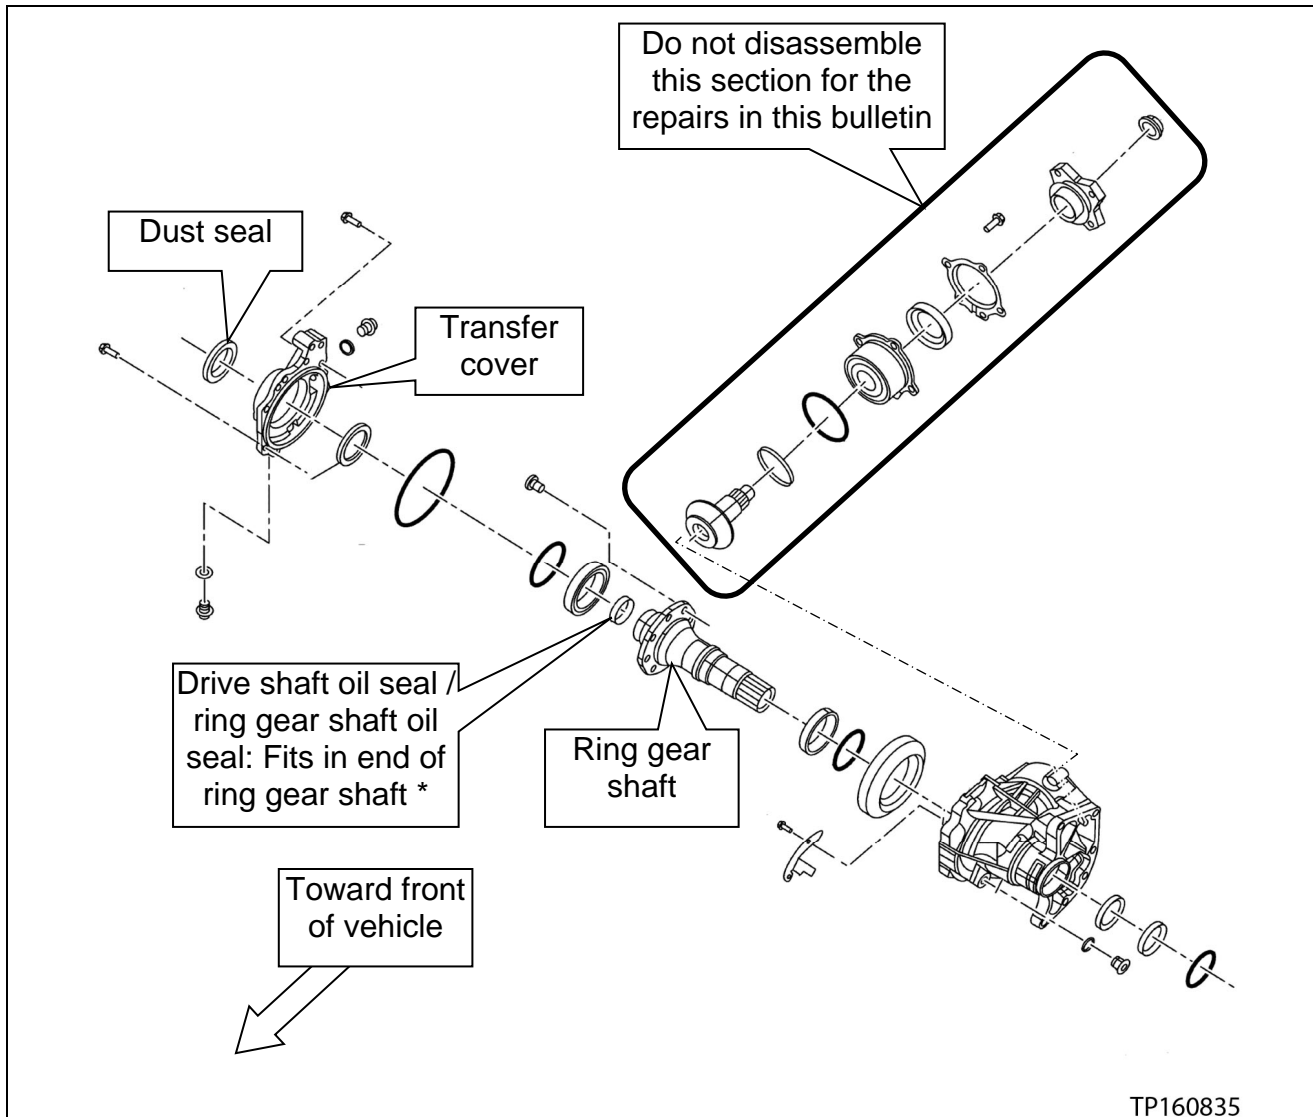
Figure 6

* The seal causing the leak is called "Drive shaft oil seal" in the ESM for all applied models except Rogue, Rogue Hybrid, Rogue Sport, and Altima. For these vehicles, it is called "Ring gear shaft oil seal".

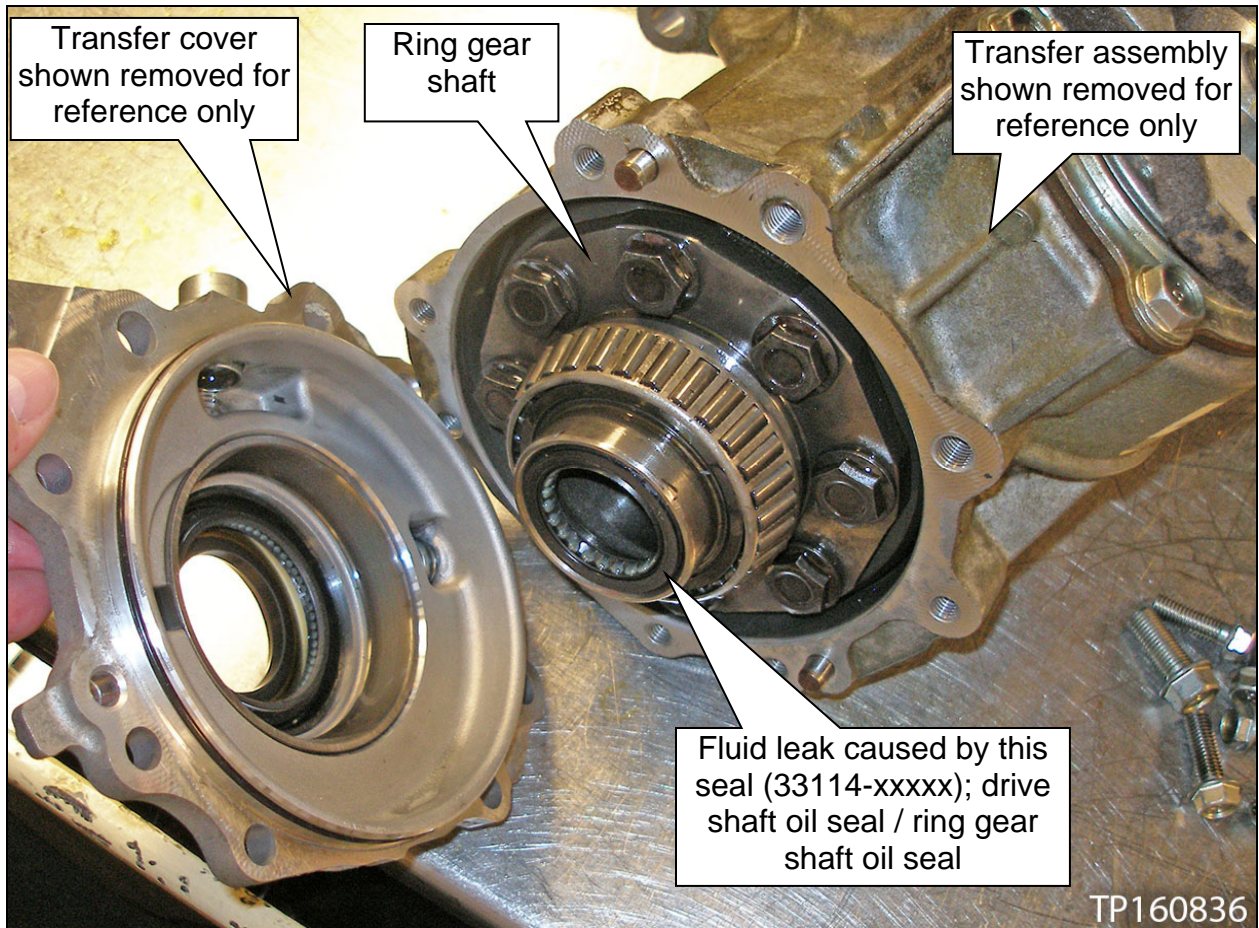
- This repair does NOT require transfer assembly removal from the vehicle.
- This repair does NOT require transfer cover removal from the transfer assembly.
- Figure 7 shows the transfer assembly removed from the vehicle and the transfer cover removed from the transfer assembly for reference only.

To avoid damage to the transfer assembly and new seals, use an appropriate seal installer and seal protector during the repair.
