SERVICE BULLETIN

Classification: HA21-002C	Reference: NTB21-071C	Date: June 27, 2022
------------------------------	--------------------------	------------------------

AUTO HVAC CENTER VENT TEMPERATURE DIFFERENCE GREATER THAN 5°C (9°F)

- APPLIED VEHICLES:** 2021 Rogue (T33)
APPLIED DATES: VINs starting with 5N1 – built before March 25, 2021
VINs starting with JN8 – built before April 22, 2021
APPLIED ENGINES: PR25DD ONLY

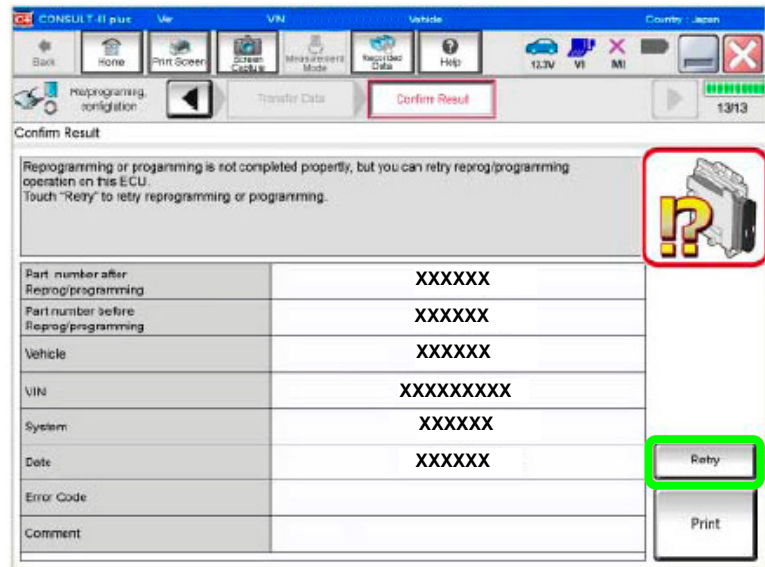
Figure 14

If reprogramming does not complete, and the “!?” icon displays as shown in Figure 14:

- Check battery voltage (12.0 V – 15.5 V).
- Ignition is ON, engine is OFF.
- External Bluetooth® devices are OFF.
- All electrical loads are OFF.
- Select retry and follow the on screen instructions.
- “Retry” may not go through on first attempt and can be selected more than once.

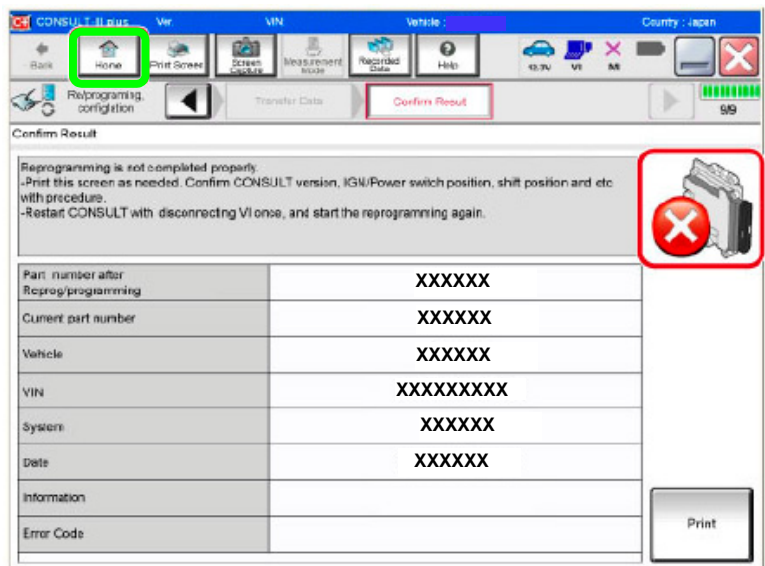
Figure 15

If reprogramming does not complete, and the “X” icon displays as shown in Figure 15:

- Check battery voltage (12.0 V – 15.5 V).
- CONSULT A/C adapter is plugged in.
- Ignition is ON, engine is OFF.
- Transmission is in Park.
- All C-III plus / VI cables are securely connected.
- All C-III plus updates are installed.
- Select Home, and restart the reprogram procedure from the beginning.
