# TECHNICAL SERVICE BULLETIN

Classification: EL22-011	Reference: NTB22-051	Date: June 17, 2022
-----------------------------	-------------------------	------------------------

## HORN INOPERATIVE

**APPLIED VEHICLES:**  
2019-2022 Altima (L34)  
2018-2022 Kicks (P15)  
2018-2022 LEAF (ZE1)  
2020-2022 Sentra (B18)  
2020-2022 Versa (N18)

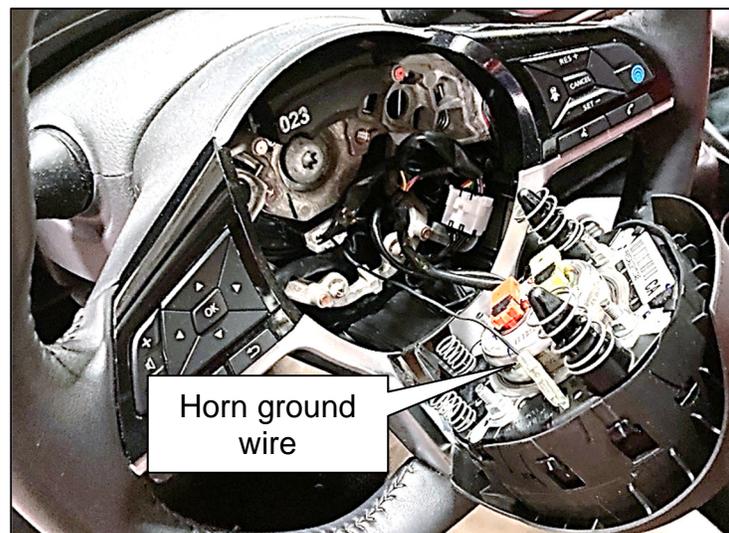
Figure 7

9. Inspect the horn ground wire for signs of pinching.
  - If signs of a pinched ground wire are present, proceed to step 10 to replace the high and low horns.
  - If signs of a pinched ground wire are not present, skip to step 11 on page 6 to install the driver airbag module.

10. Replace the high and low horn.
  - Refer to the ESM: **DRIVER CONTROLS > HORN > REMOVAL AND INSTALLATION – HORN: Removal and Installation**

The pinched ground wire does not require a wire repair. When installing the driver airbag module to the steering wheel, rotate the driver airbag module 360° to remove excess slack from the ground wire and to prevent the ground wire from becoming pinched.
