**POOR A/C PERFORMANCE DUE TO LEAKING REFRIGERANT
FROM THE AIR CONDITIONER CONDENSER PIPE**

Bulletin No.: 07-003/22

2016-2022 CX-9

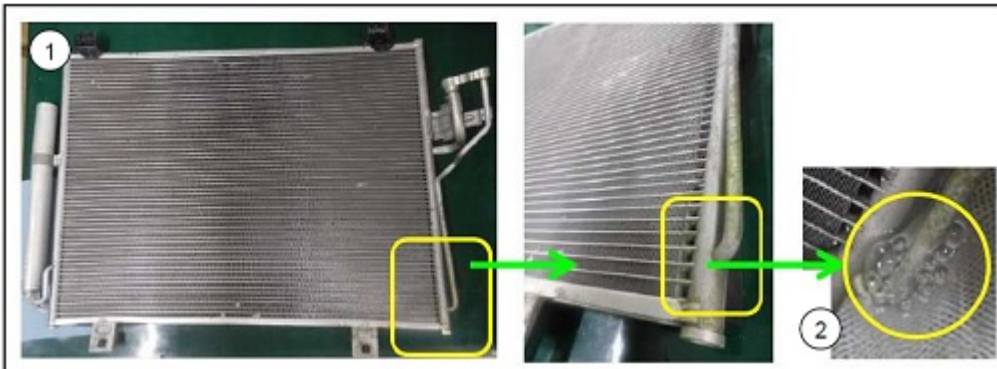
Some customers may complain about poor A/C performance due to low refrigerant. This may be caused by the low-temperature side outlet pipe leading to the evaporator of the air conditioner condenser deteriorating because the structure around the outlet pipe on the low-temperature side of the air conditioner condenser allows mud and salt water to adhere easily. There is no mass production change, but an improved condenser was designed as needed.

1. Verify the customer concern.
2. Use a gas leak tester or a fluorescent agent-detecting UV black light to check if there is a leak from the condenser (1) from the area shown (2) in the figure.

- If gas leaks from this area, replace the condenser with a modified one.
 - 2016-2020 CX-9 (CONDENSOR REMOVAL/INSTALLATION)
 - 2021-2022 CX-9 (CONDENSOR REMOVAL/INSTALLATION)
 - If there is no gas leak from this area, troubleshoot the poor A/C performance according to the instructions on MGSS.
3. Verify the repair.
