# Technical Service Bulletin

<b>Subject:</b>  LIFTGATE SWITCH DOES NOT WORK	<b>Bulletin No.:</b> 09-004/22
	<b>Last Issued :</b> 08/08/2022

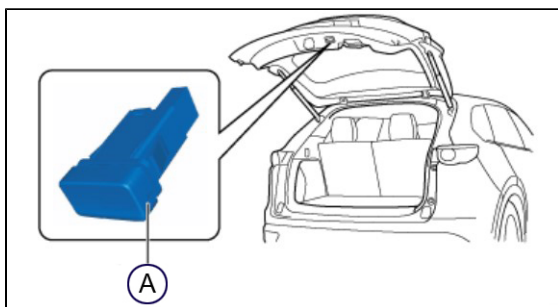
**NOTE:** CX-5 shown below

Some CX-5 and CX-30 customers may find that the liftgate does not close when pressing the power liftgate (PLG) rear switch (A) located on the interior liftgate trim. This may be caused by PLG switch corrosion. Water from a high pressure car washer and/or condensation may drip onto the switch connector and cause corrosion.

To eliminate this concern, the PLG rear switch has been modified with a waterproof connector.
