Subject: WHEN REPLACING BCM, SOME ECU MAY NEED REPROGRAMMING	Bulletin No.: 09-027/22
	Last Issued : 08/03/2022

DESCRIPTION

When replacing the body control module (BCM), some ECUs may need reprogramming. Without reprogramming the concerned ECUs, the power saving function may not work properly.

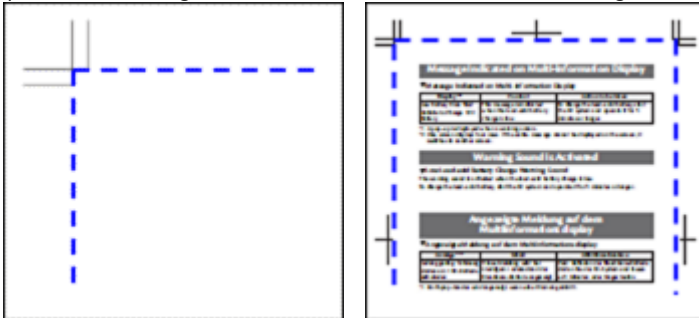
(Before handing the leaflet to a customer, cut the alignment marks on each corner as shown in blue broken lines.)

1. Explain the low battery warning function to the customer using the attached leaflet.

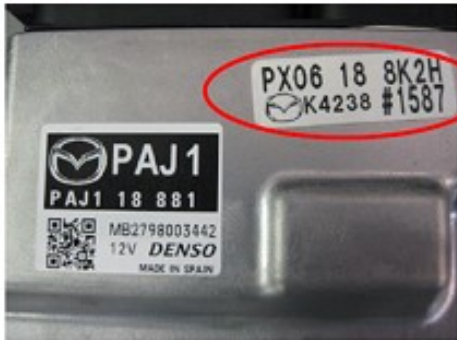
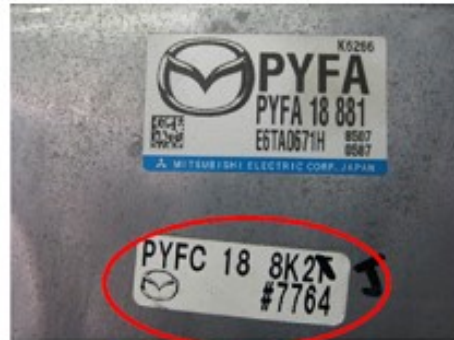
- If DTC U2120:00 or/and U2500:82 are stored and i-ACTIVSENSE warning light (amber) turns on after the reprogramming, refer to SA-043/20.
- If the Welcome Lamp function is accidentally activated while using MDARS, it may also cause this concern. Check and correct as necessary. Refer to the SA-054/20 for details.
- If MDARS requires Manual PCM Software Number Entry, perform the following:
 - Look for the small sticker on the PCM that has the software number “**** 18 8K2*” printed on it.

- Enter the software number adding “-” instead of a space.
Example: If “PX06 18 8K2H” is printed, enter “PX06-18-8K2H”.
- **NOTE:** Entering the wrong Software Number may lead to inappropriate software downloading and could result in abnormal operation of the vehicle.
