Technical Service Bulletin

| Subject: BATTERY DISCHARGED DUE TO SEAT VENTILATION MALFUNCTION | Bulletin No.: 09-032/22 |
| | Last Issued : 08/22/2022 |

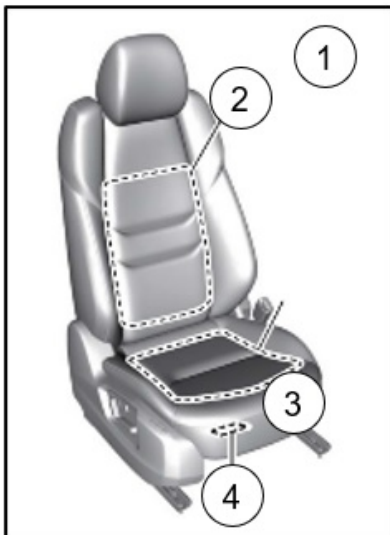
Some vehicles may experience the seat ventilation system still on after the engine has been turned off, in some cases this causes the battery to be completely discharged and not rechargeable. This is caused by a deterioration in the seat ventilation control unit. To eliminate this concern, the material for the circuit of the seat ventilation control unit has been modified.

- (1) Passenger side
- (2) Seat ventilation unit (Seat back side)
- (3) Seat ventilation unit (Seat cushion side)
- (4) Seat ventilation control unit

2. Replace the front seat warmer control unit according to the instructions on MGSS (FRONT SEAT WARMER CONTROL UNIT REMOVAL/INSTALLATION).

NOTE: The front seat ventilation control unit is integrated with the front seat warmer control unit located on the bottom of the passenger side front seat.
