TECHNICAL SERVICE BULLETIN

| Classification: AT15-006C | Reference: ITB15-011C | Date: May 17, 2022 |

ENHANCED DIAGNOSTIC LOGIC FOR CVT JUDDER

| APPLIED VEHICLES: | 2013 JX35 (L50) 2014 – 2015 QX60 (L50) |

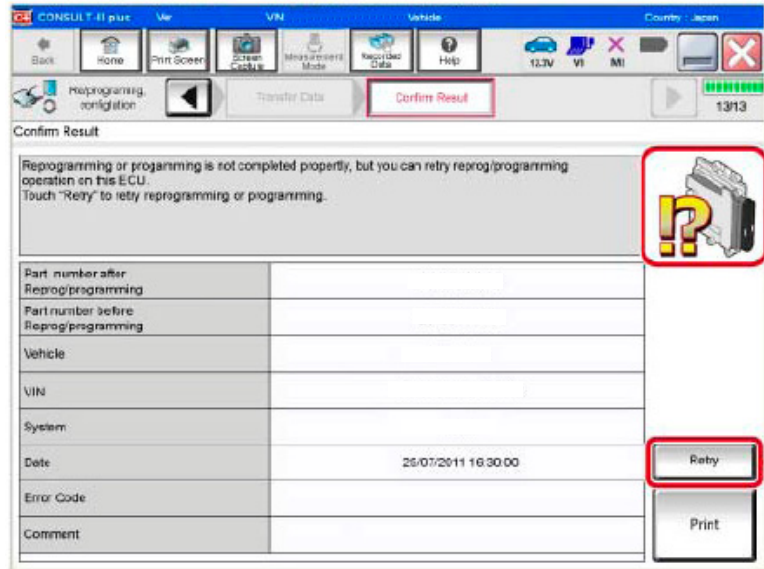
Figure 5

If reprogramming does not complete, and the “!” icon displays as shown in Figure 5:

- Check battery voltage (12.0–15.5 V).
- Ignition is ON, engine OFF.
- External Bluetooth® devices are OFF.
- All electrical loads are OFF.
- Select retry and follow the on screen instructions.
- “Retry” may not go through on first attempt and can be selected more than once.

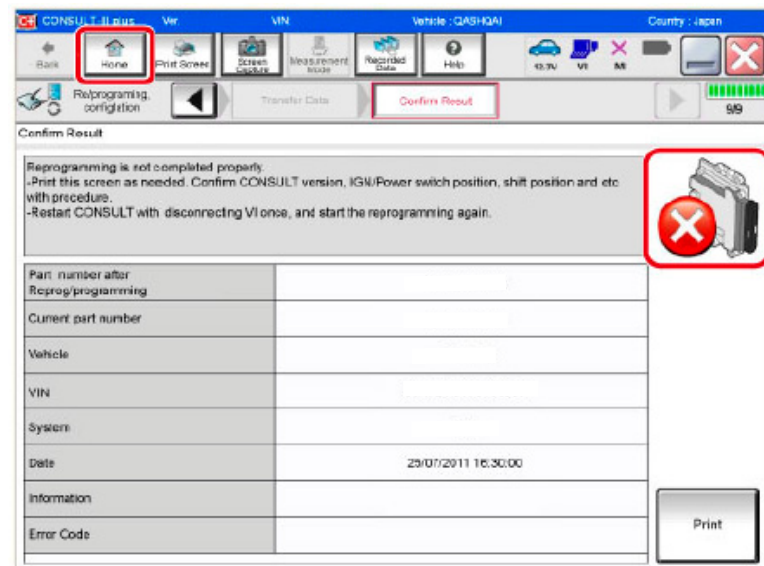
Figure 6

If reprogramming does not complete, and the “X” icon displays as shown in Figure 6:

- Check battery voltage (12.0 – 15.5 V).
- CONSULT A/C adapter is plugged in.
- Ignition is ON, engine OFF.
- Transmission is in Park.
- All C-III plus / VI cables are securely connected.
- All C-III plus updates are installed.
- Select Home, and restart the reprogram procedure from the beginning.

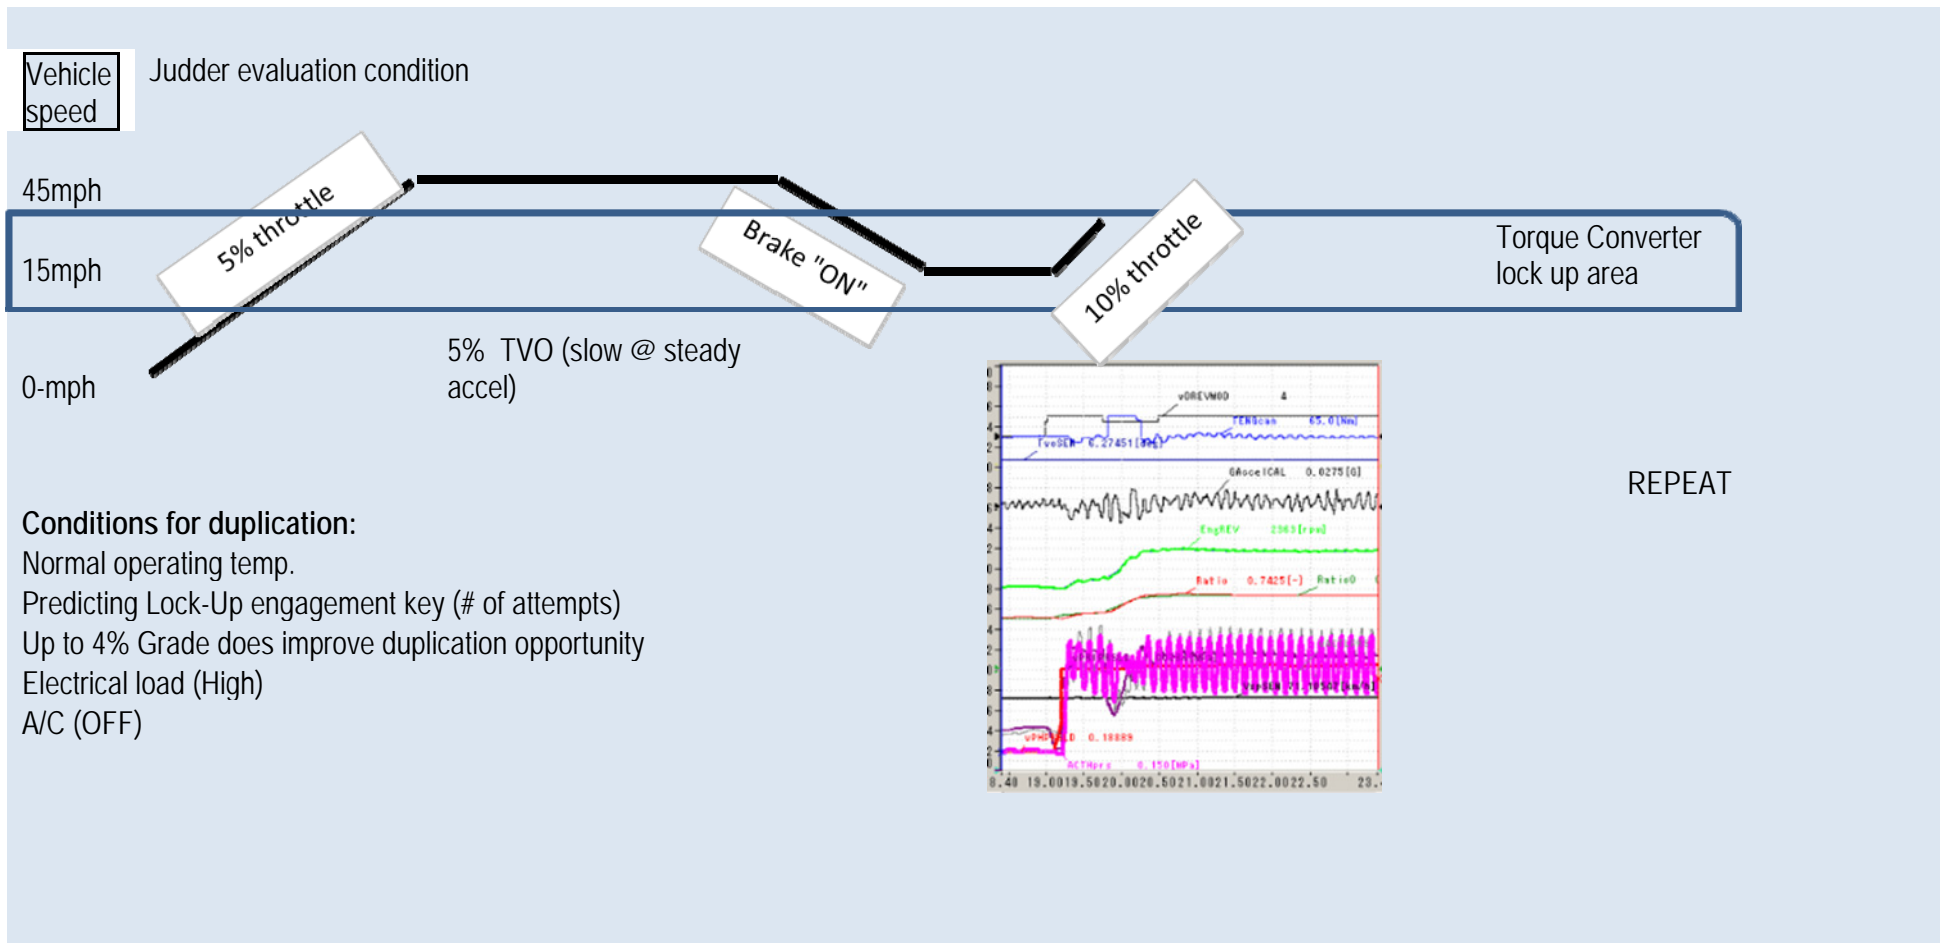
Figure 8

- This new diagnostic logic will monitor conditions in the CVT and provide a more precise diagnosis of any potential issues with the CVT.
- Figure 8, on the next page, illustrates conditions under which judder can be reproduced.
- Specific drive conditions that can be used to test for judder (shake, shudder, single or multiple bumps or vibration) are:
 1. Slowly accelerate from a stop (zero mph), applying only slight accelerator pedal (**0% - 10% throttle opening**) until 40 mph is reached.
 - During acceleration, torque converter engagement (full lock up) can occur between 20-35 mph.
 2. Prior to torque converter lock up, slowly modulate the accelerator pedal:
 - a. Decrease the accelerator pedal pressure slowly, approaching a closed throttle position.
 - b. Smoothly and slowly reapply accelerator pedal pressure back to approximately 10% throttle opening.

- Figure 8, below, illustrates conditions under which judder can be reproduced.

- Slight grade (climbing hill) may aid in performing the above drive conditions.
- DTC detection logic will require three events before storing a DTC.
- If DTC P17F1 or P17F0 is stored, refer to ITB15-012 for repair information.
