TECHNICAL SERVICE BULLETIN

Classification: AT14-014C	Reference: NTB15-014C	Date: May 17, 2022
------------------------------	--------------------------	-----------------------

ENHANCED DIAGNOSTIC LOGIC FOR CVT JUDDER

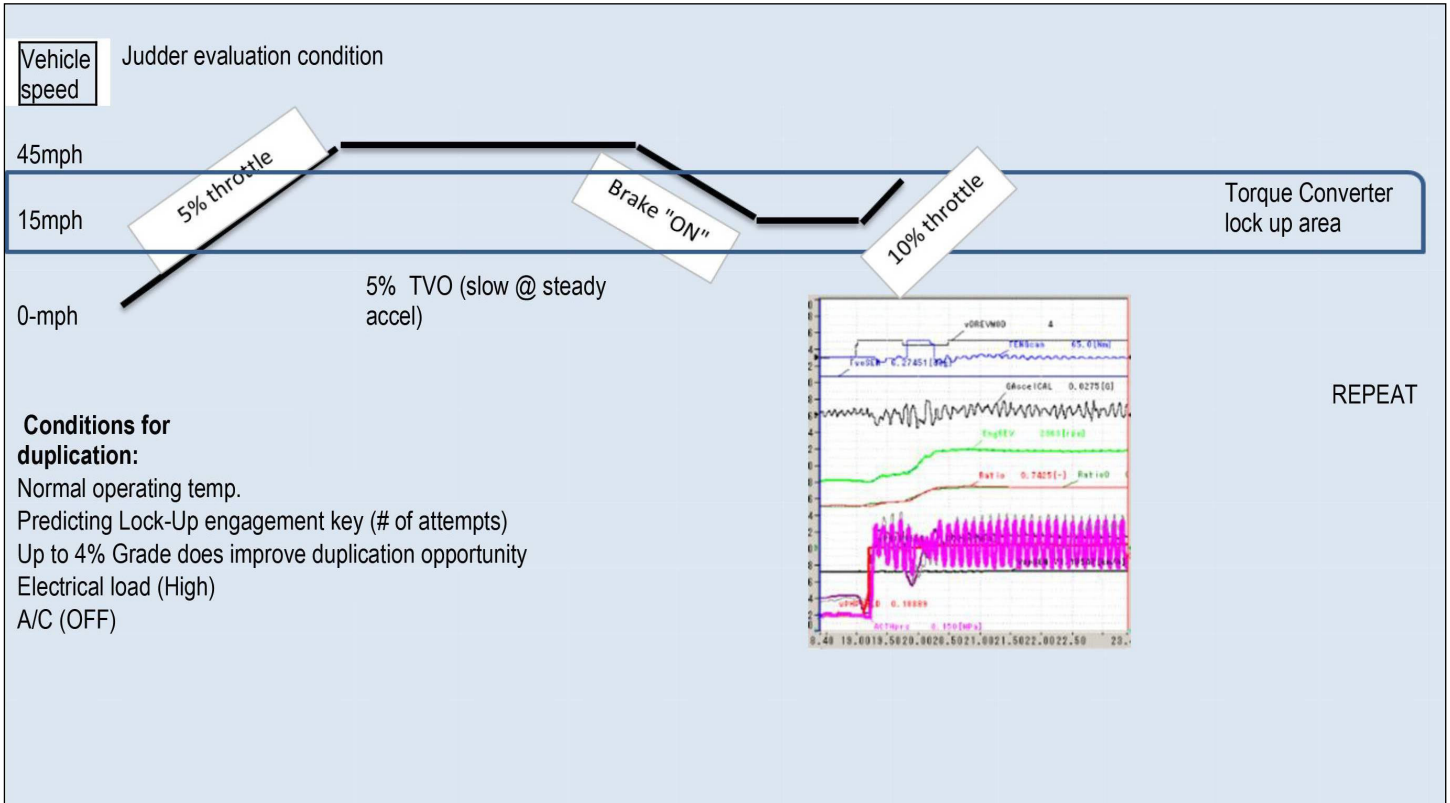
Figure 8

DTC detection drive pattern for P17F0 / P17F1

- This new diagnostic logic will monitor conditions in the CVT and provide a more precise diagnosis of any potential issues with the CVT.
- Figure 8, on the next page, illustrates conditions under which judder can be reproduced.
- Specific drive conditions that can be used to test for judder (shake, shudder, single or multiple bumps or vibration) are:
 1. Slowly accelerate from a stop (zero mph), applying only slight accelerator pedal **(0% - 10% throttle opening)** until 40 mph is reached.
 - During acceleration, torque converter engagement (full lock up) can occur between 20-35 mph.
 2. Prior to torque converter lock up, slowly modulate the accelerator pedal:
 - a. Decrease accelerator pedal pressure slowly, approaching a closed throttle position.
 - b. Smoothly and slowly reapply accelerator pedal pressure back to approximately 10% throttle opening.

- Slight grade (climbing hill) may aid in performing the above drive conditions.
- DTC detection logic will require three events before storing a DTC.
