TECHNICAL SERVICE BULLETIN

Classification: AT15-011A	Reference: NTB15-083A	Date: May 17, 2022
------------------------------	--------------------------	-----------------------

ENHANCED DIAGNOSTIC LOGIC FOR CVT JUDDER

APPLIED VEHICLES: 2013-2015 Altima (L33)
2014-2016 Rogue (T32)
APPLIED ENGINES: 4 cylinder engine only
APPLIED TRANSMISSIONS: CVT

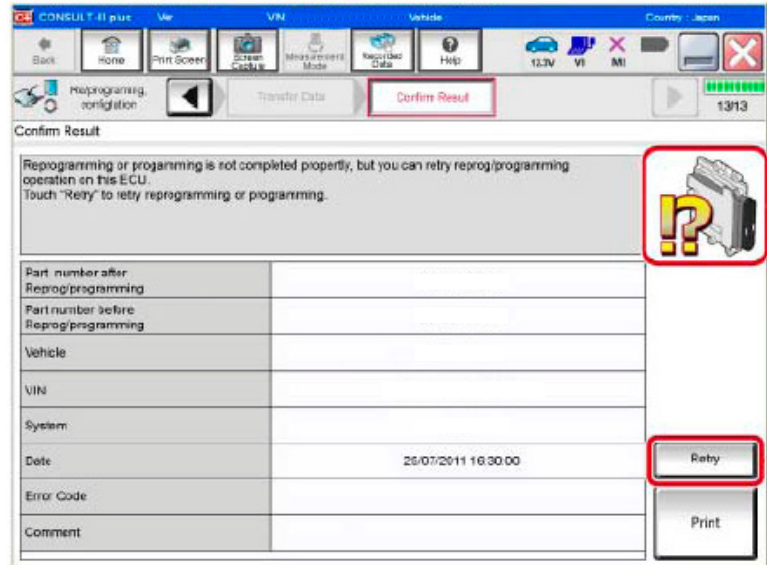
Figure 5

If reprogramming does not complete, and the “!?” icon displays as shown in Figure 5:

- Check battery voltage (12.0–15.5 V).
- Ignition is ON, engine OFF.
- External Bluetooth® devices are OFF.
- All electrical loads are OFF.
- **Select retry and follow the on screen instructions.**
- “Retry” may not go through on first attempt and can be selected more than once.

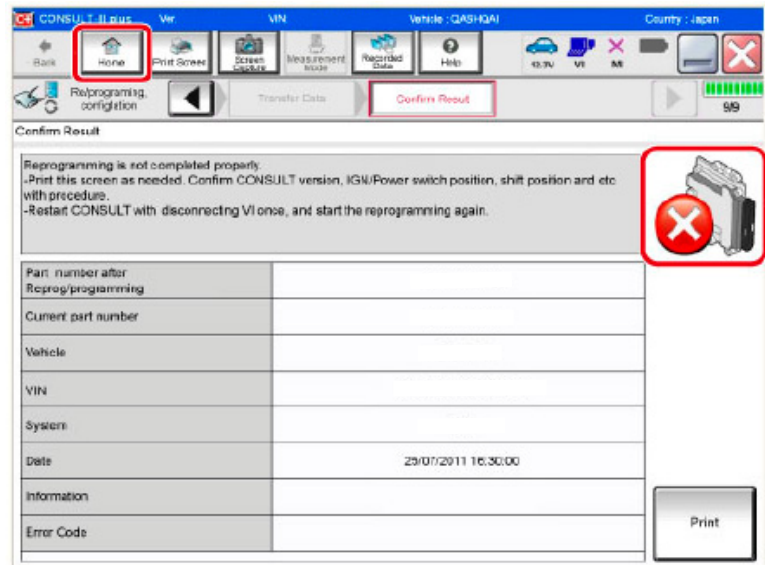
Figure 6

If reprogramming does not complete, and the “X” icon displays as shown in Figure 6:

- Check battery voltage (12.0 – 15.5 V).
- CONSULT A/C adapter is plugged in.
- Ignition is ON, engine OFF.
- Transmission is in Park.
- All C-III plus / VI cables are securely connected.
- All C-III plus updates are installed.
- **Select Home, and restart the reprogram procedure from the beginning.**

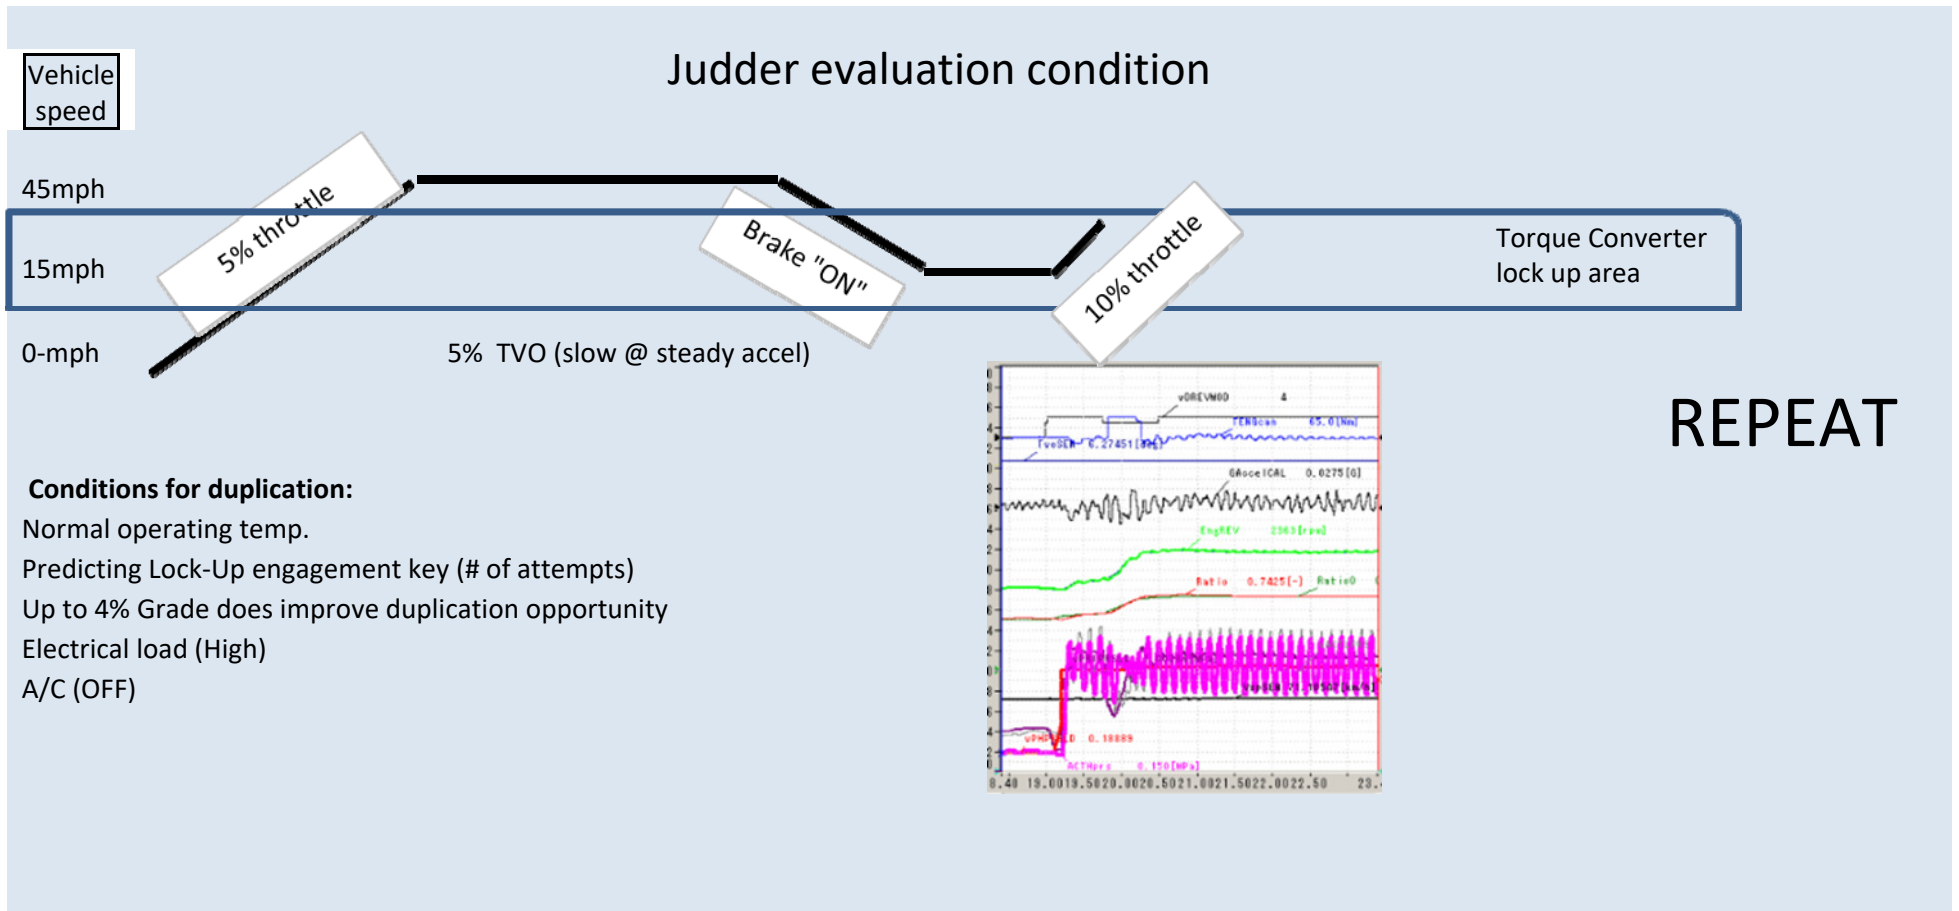
Figure 8

- This new diagnostic logic will monitor conditions in the CVT and provide a more precise diagnosis of any potential issues with the CVT.
- Figure 8, on the next page, illustrates conditions under which judder can be reproduced.
- Specific drive conditions that can be used to test for judder (shake, shudder, single or multiple bumps or vibration) are:
 1. Slowly accelerate from a stop (zero mph), applying only slight accelerator pedal (**0% - 10% throttle opening**) until 40 mph is reached.
 - During acceleration, torque converter engagement (full lock up) can occur between 20-35 mph.
 2. Prior to torque converter lock up, slowly modulate the accelerator pedal:
 - a. Decrease accelerator pedal pressure slowly, approaching a closed throttle position.
 - b. Smoothly and slowly reapply accelerator pedal pressure back to approximately 10% throttle opening.

- Figure 8, below, illustrates conditions under which judder can be reproduced.

- Slight grade (climbing hill) may aid in performing the above drive conditions.
- DTC detection logic will require three events before storing a DTC.
- If DTC P17F1 or P17F0 is stored, refer to NTB15-084 for repair information.
