TECHNICAL SERVICE BULLETIN

Classification: BT21-020A	Reference: NTB21-097A	Date: May 10, 2022
------------------------------	--------------------------	-----------------------

WATER LEAK AT TOP FRONT CORNERS OF WINDSHIELD

APPLIED VEHICLES: 2021-2022 Rogue (T33)
APPLIED GRADES: All with roof rails or roof side moldings

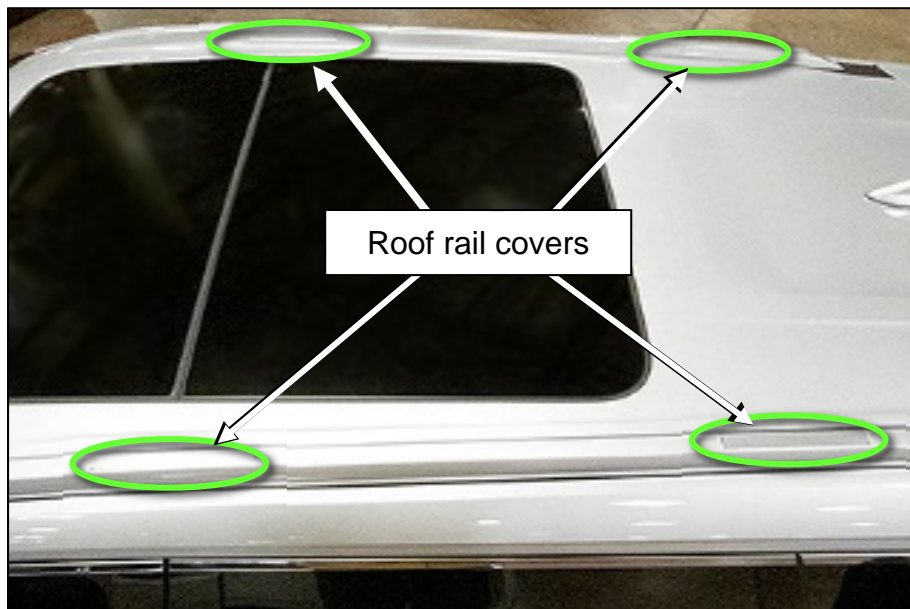
Figure 1

HINT: Vehicles that do not have cross bars will have roof rail covers over the bolts that are intended to hold the cross bars, as shown in Figure 1, Figure 2 and removed in Figure 3.

1. For “S” and “SV” grade vehicles that are equipped with roof side moldings (lay flat and do not have cross bar mounting bolts), skip to step 3.
2. Access the cross bar (roof rack) mounting bolts.
 - If cross bars are mounted, remove all eight (8) cross bar mounting bolts on the LH and RH sides of the vehicle, and then remove both cross bars from the vehicle.
 - If cross bars are not mounted, as shown in Figure 1, remove the four (4) roof rail covers and then all eight (8) bolts.
