TECHNICAL SERVICE BULLETIN

Classification: EM22-004	Reference: NTB22-045	Date: May 25, 2022
-----------------------------	-------------------------	-----------------------

RATTLE OR KNOCK NOISE FROM FRONT WHEN DRIVING OVER BUMPS AND/OR TURNING

APPLIED VEHICLES: 2021-2022 Sentra (B18)
APPLIED DATES: Built from January 2, 2021 to February 23, 2022

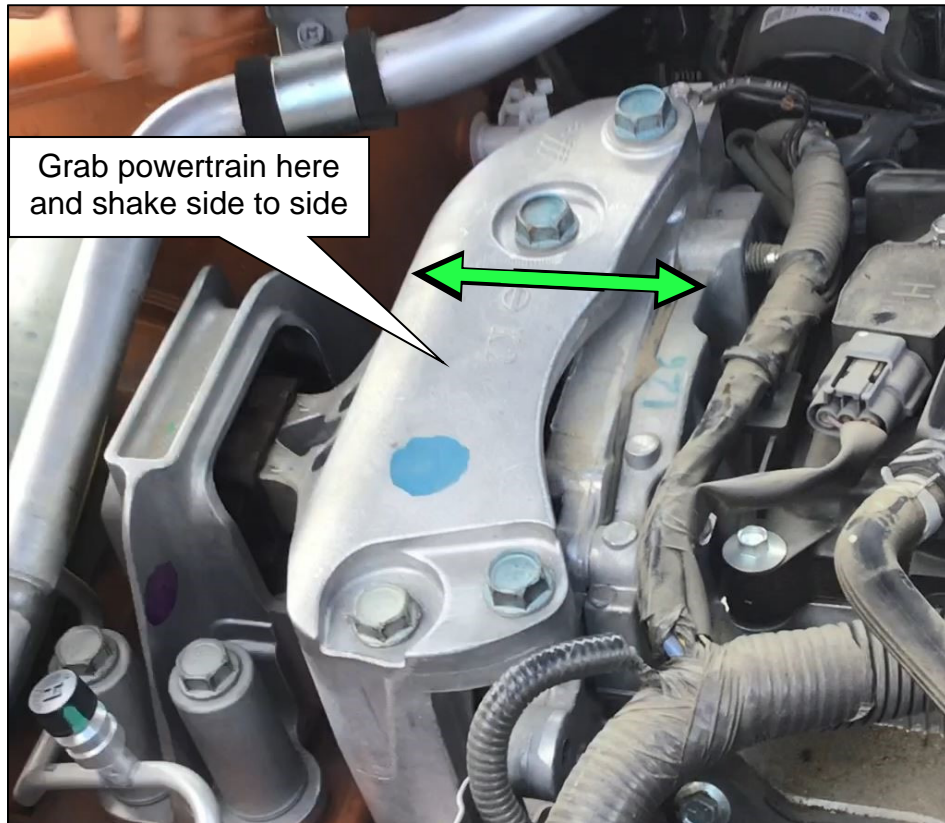
Figure 1

1. Confirm the noise is coming from the Engine Mounting Insulator (RH) as follows:
 - a. Turn the engine OFF.
 - b. Open the hood.
 - c. Grab the Engine Mounting Insulator (RH) at the location shown in Figure 1, and shake the powertrain side to side.

- If a rattle or knock is NOT present when shaking the powertrain side to side, proceed to **CLAIMS INFORMATION** on the next page. Refer to ASIST for further diagnostic and repair information.
- If a rattle or knock is present when shaking the powertrain side to side, replace the Engine Mounting Insulator (RH).
 - Refer to the ESM: **ENGINE > ENGINE MECHANICAL > MR20DD > REMOVAL AND INSTALLATION > ENGINE MOUNTING INSULATOR (RH)**
