TECHNICAL SERVICE BULLETIN

| Classification: AN22-015 | Reference: NTB22-047 | Date: May 31, 2022 |

SOFTWARE UPDATE FOR INFOTAINMENT ISSUES

APPLIED VEHICLES: 2022 Titan/Titan XD (A61)

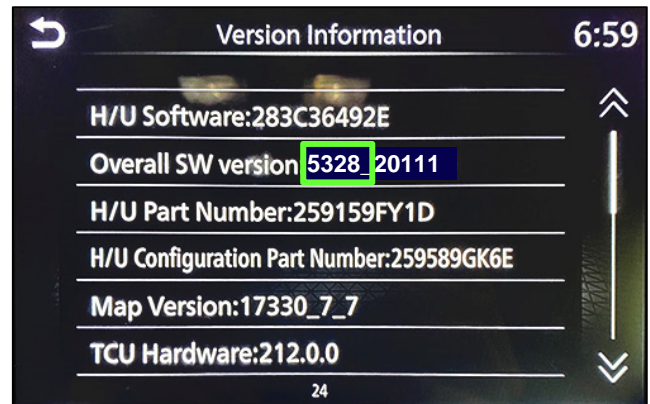
Figure 5

4. Confirm if the **Overall SW version** begins with "5328".

- If the **Overall SW version** begins with "5328", select the back button; this bulletin does not apply.
- If the **Overall SW version** does NOT begin with "5328", select the back button and then continue to step 5 on page 5.

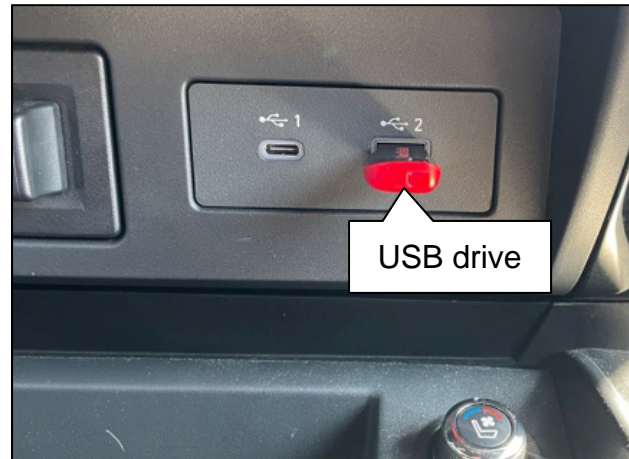
Figure 11

16. Insert the USB drive with the infotainment update-software into the vehicle's USB media port (see Figure 11).

Do not insert the USB drive into a charging port. If used, the update-software and/or USB drive may become damaged. Only insert the USB drive in a USB media port.

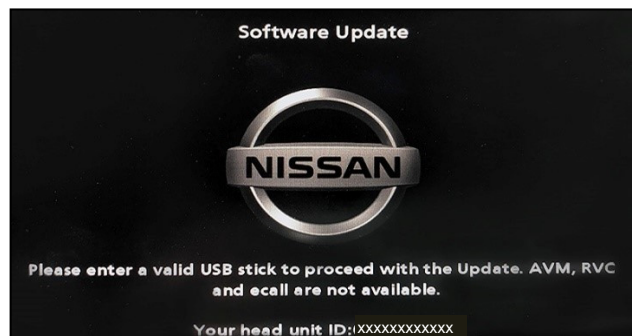
- The screen in Figure 13 may briefly appear. **Do not remove the USB drive.** The audio system will detect the USB drive and continue the update.
