CAMPAIGN BULLETIN

Left Front Coil Spring Dealer Inventory

Reference: PC891
Date: May 20, 2022

PC891 – 2022 ALTIMA LEFT FRONT COIL SPRING

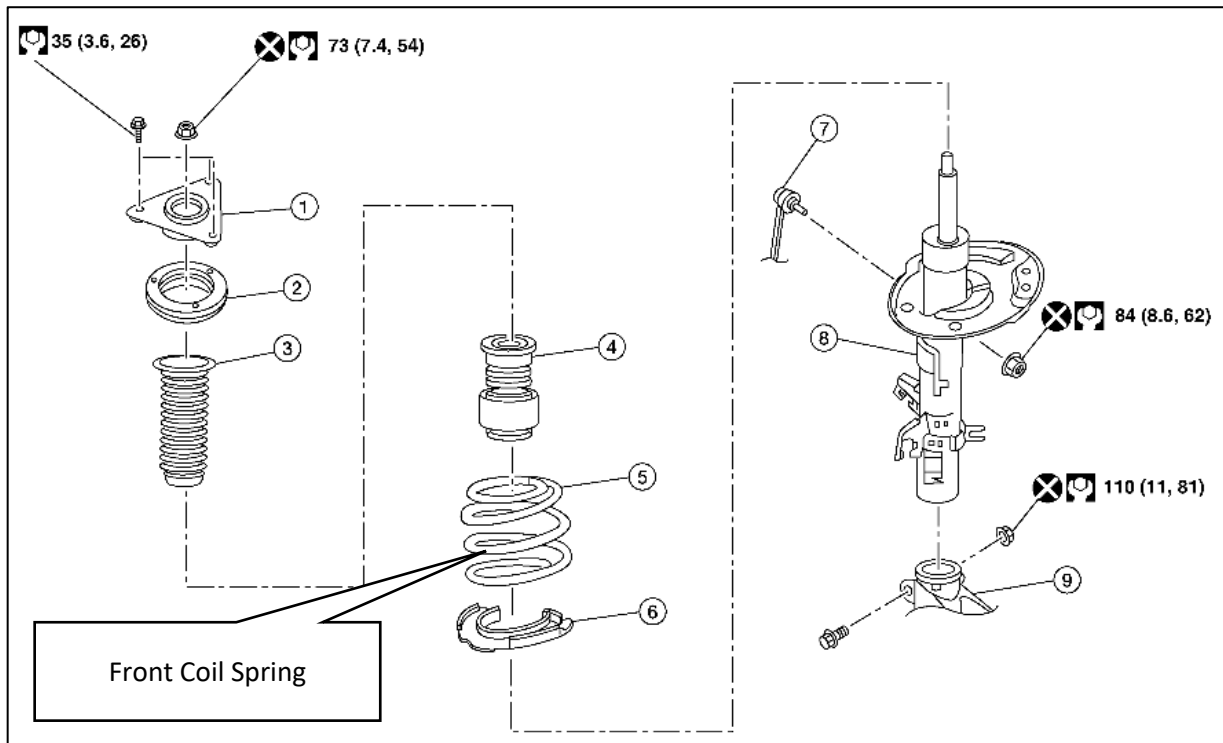
1.	Strut mount insulator	2.	Strut mount bearing	3.	Front spring upper rubber seat
4.	Front suspension bound bumper	5.	Front coil spring	6.	Front spring lower rubber seat
7.	Stabilizer connecting rod	8.	Strut	9.	Steering knuckle

1. Replace the left front (Driver Side) coil spring.
 - For front coil spring replacement refer to the Electronic Service Manual (ESM) section: *SUSPENSION > FRONT SUSPENSION > REMOVAL AND INSTALLATION > FRONT COIL SPRING AND STRUT > Removal and Installation*

The following one-time use nuts **MUST** be replaced and torqued to the ESM specification listed below:

1. Top Strut Nut > 73 N•m (7.4 kg-m, **54 ft-lb**)
 2. Stabilizer Connecting Rod Nut > 84 N•m (8.6 kg-m, **62 ft-lb**)
 3. Outer Socket Nut > 34.4 N•m (3.5 kg-m, **25 ft-lb**)
 4. Steering Knuckle Upper Nut > 110 N•m (11 kg-m, **81 ft-lb**)
 5. Steering Knuckle Lower Nut > 97.5 N•m (9.9 kg-m, **72 ft-lb**)
 6. Wheel Hub Lock Nut > 110 N•m (11 kg-m, **81 ft-lb**)
7. Strut Mount Insulator Bolts (Can Reuse) > 35 N•m (3.6 kg-m, **26 ft-lb**)
