Service Bulletin

Bulletin No.: 17-NA-221

Subject: Poor Engine Performance in Extremely Cold Weather Conditions for LE2 Engines, Charge Air Cooler Icing - Malfunction Indicator Lamp (MIL) Illuminated, DTC P0299, P0234, P0236, P2227, P00C7 Set

Brand:	Model:	Model Year:		VIN:		Engine:	Transmission:
		from	to	from	to		
Buick	Encore	2016	2019	—	—	1.4L (LE2)	—
		2021	2022				
Chevrolet	Trax	2021	2022

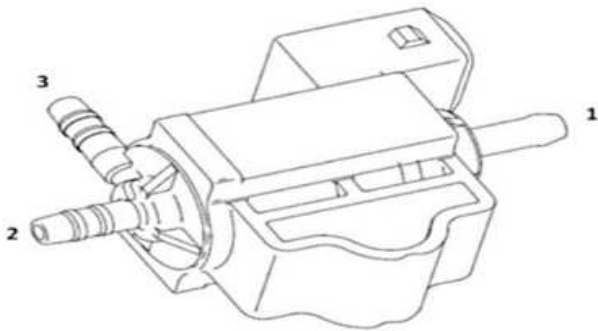
6055068

Note: Check port #2 to assure the spring gets lifted off the seat. This will be determined by the compressed air not dead heading when applied to port #2. When applying air to this port a small amount of air should be observed at port #3 and even less air will be noticed at port #1. If this does not happen, the TCV plunger may have hardened deposits from hot operating conditions which will impede TCV plunger movement, and the turbocharger wastegate regulator solenoid valve should be replaced.

3. Using clean shop air regulated to 80-100 PSI, blow through all three ports (1, 2 & 3) for 5 seconds each.

⇒ Repeat step 3 twice.

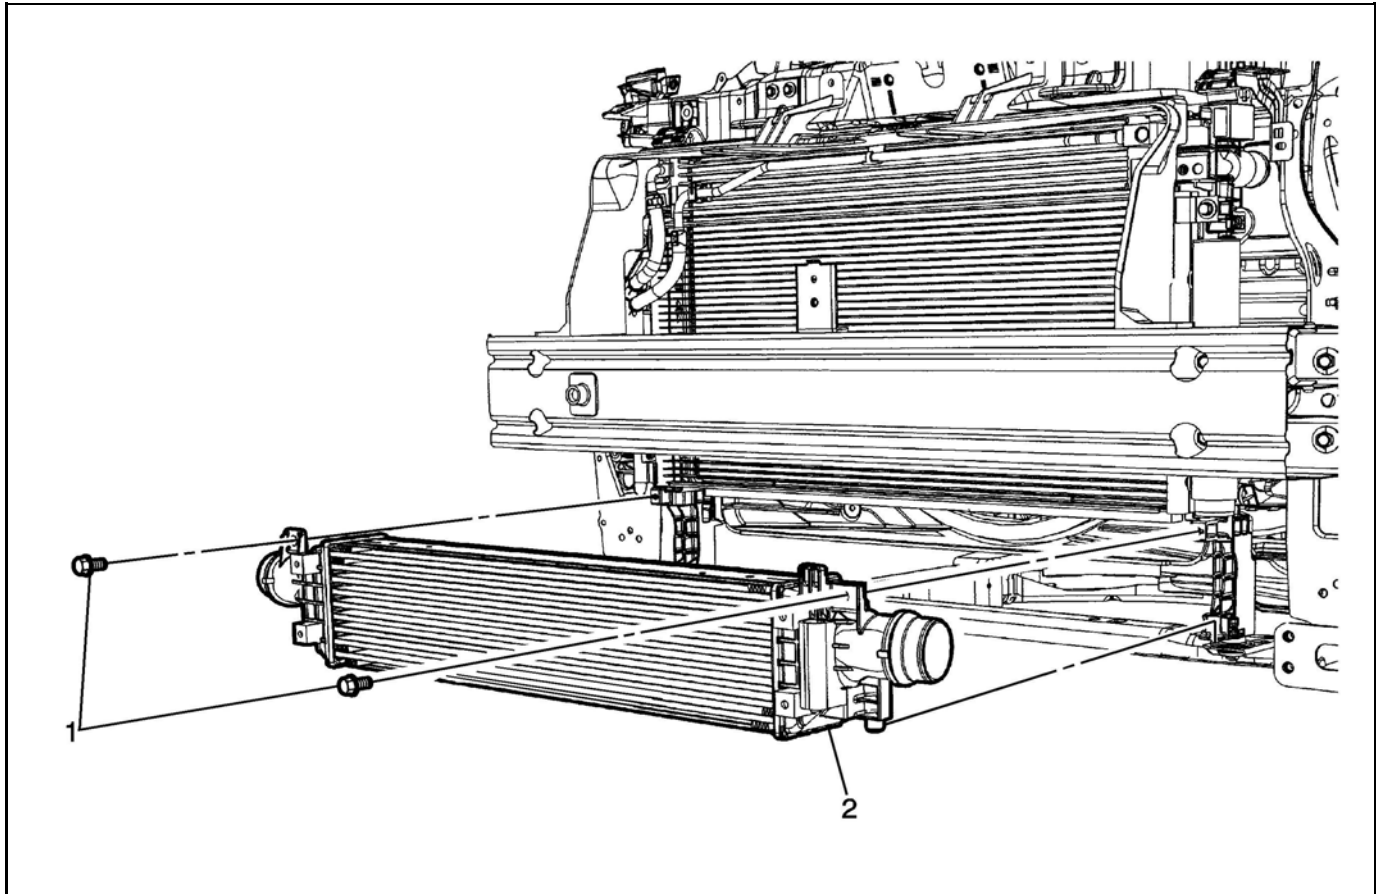
2851444

Cause	This condition may be caused by ice accumulation in the charge air cooler (CAC), restricting air flow to the throttle body.

1. Install the CAC (2). Refer to *Charge Air Cooler Replacement* in SI.
