# Service Bulletin

Bulletin No.: 20-NA-020

**Subject: Brake Squealing Noise**

Brand:	Model:	Model Year:		Vehicle Build Date:		Engine:	Transmission:
		from	to	from	to		
Chevrolet	Silverado 2500HD/3500HD	2020	2022				
GMC	Sierra 2500HD/3500HD

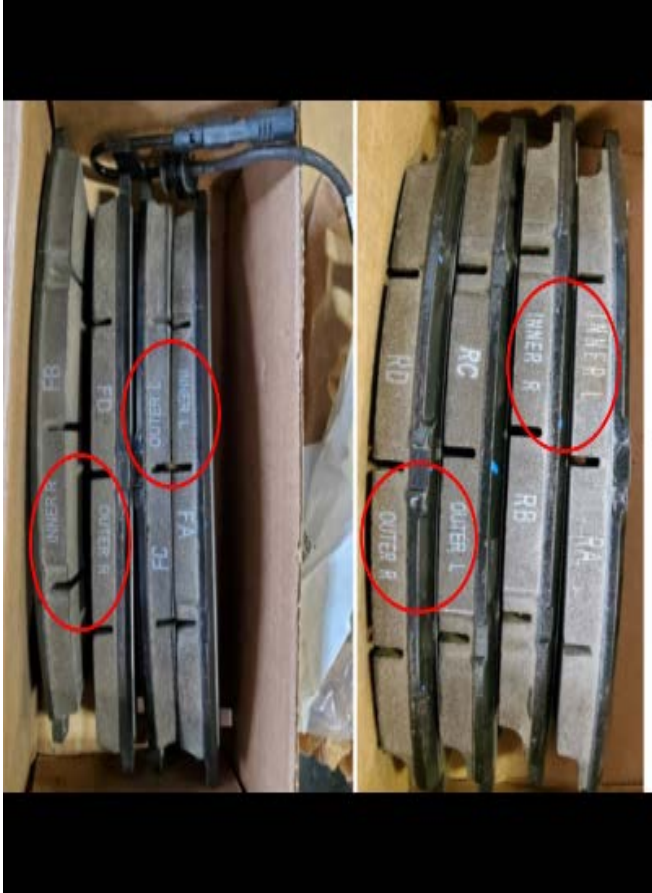
<p><b>Involved Region or Country</b></p>	<p>United States, Canada, Mexico, Middle East, Israel, Australia and New Zealand.</p>
<p><b>Condition</b></p>	<p>Some customers may comment that the brakes are squealing.</p>
<p><b>Cause</b></p>	<p>This condition may be caused by a lining shim material not effectively reducing noise.</p>
<p><b>Correction</b></p>	<p><b>Note:</b> To increase the effectiveness of this repair, a brake burnish should be performed during the test drive to properly prepare the pads to the rotors. Refer to <b>Brake Pad and Rotor Burnishing</b> in SI for the procedure.</p> <p>Replace the front and rear brake pads.</p>
