Service Bulletin

Bulletin No.: 20-NA-156

Subject: Rear Axle Clunk

Brand:	Model:	Model Year:		VIN:		Engine:	Transmission:
		from	to	from	to		
Chevrolet	Colorado	2015	2022	-	-	-	-
GMC	Canyon

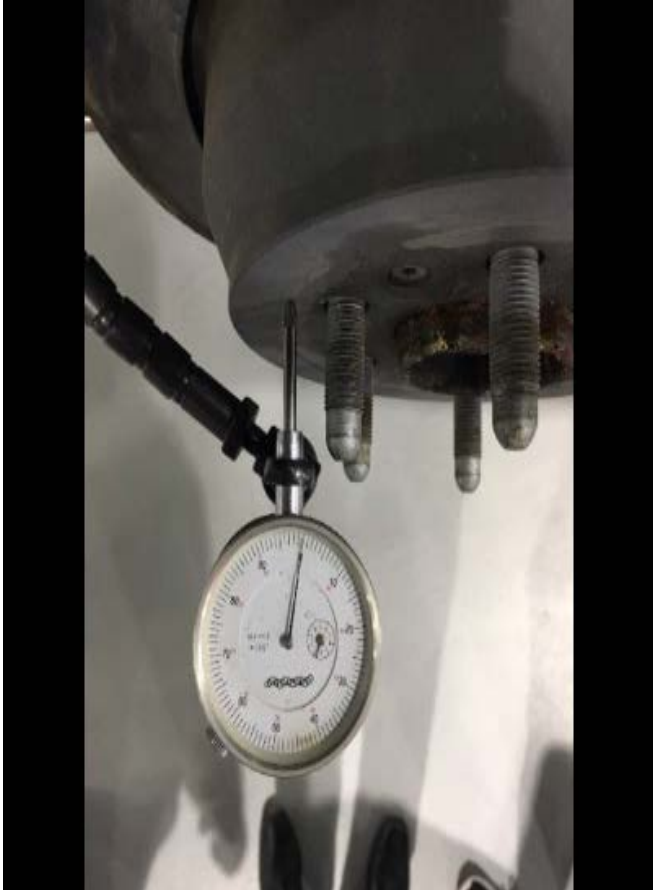
5636028

8. Record endplay measurement.
 - If endplay measurement is at 0.32mm (0.0126") or greater, then service C-locks can be installed without interference (exception detailed below).
 - **EXCEPTION** – If it is a G80 Locking Rear Axle, a C-lock can only be applied on the left hand side if it measures 0.57mm (0.0224) endplay or higher. There must be at least 0.25mm (0.010") of endplay on left had side to not damage locker.
 - If endplay is below 0.32mm (0.0126"), Service C-locks may still be installed, however, if the components (axle shaft and differential) are at the low end of the tolerance, interference may occur.
9. Repeat for opposite side.
10. Record endplay measurement.

4. Attach dial indicator to be able to measure perpendicular to center of rotor face.
5. Push in axle shaft all the way by pushing on the rotor face.
6. Zero out dial indicator at this stage.
7. Pull axle shaft outward all the way by pulling on the rotor.
