BODY & CHASSIS

Ticking / Tapping Type Noise From Upper A-Pillar Area

21 – 22MY RR Sport

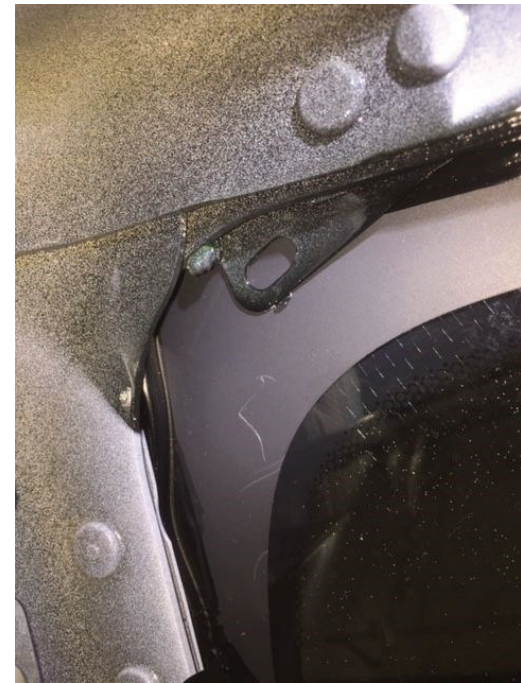
- A customer may report a ticking or tapping type noise while driving from the upper A-Pillar area.

- This may be caused by a body flange contacting the windshield glass.

- Engineering is currently investigating this concern.
- SSM 75800 has been published to address this concern.
- The body flange can be easily be repositioned away from the windshield glass without the need to remove the windshield, using a suitable tool.
- Care should be used to avoid damaging the windshield glass.
