## U0111-00 Lost Communication with Battery Energy Control Module "A"

19-22MY Range Rover(L405), RR Sport

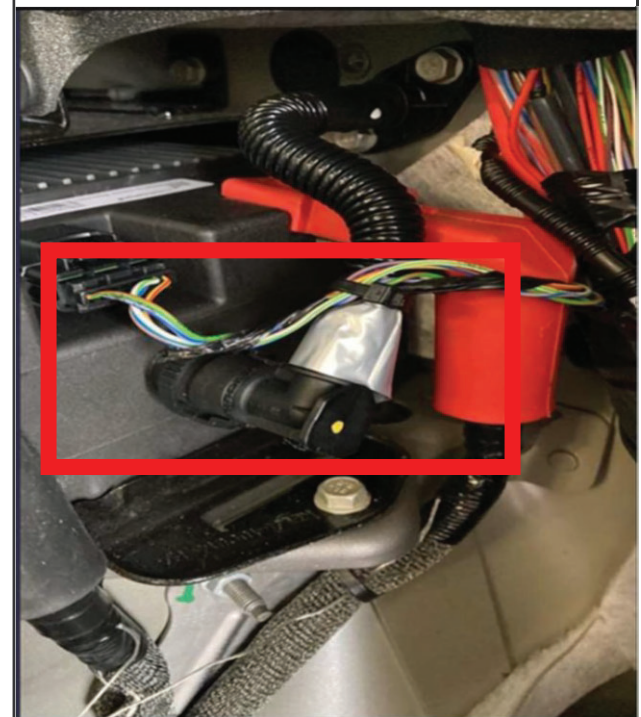
- DTC U0111-00 Lost Communication with Battery Energy Control Module "A" will come on.
- Incorrect Battery Energy Control Module (BECM) harness routing causing tension on connector C4YB01D resulting in high resistance/open circuit.

- Remove the original clipping feature on the MHEV Battery harness and replace with a suitable cable tie (200mm x 4.8mm) making sure the harness is routed correctly and not tight putting the harness under stress as per the attachment and check for connector damage and repair if required.
