Technical Service Bulletin

**97 Q7 Various warnings or functions inoperative, corroded splice points in driver sill. DTC:
U150600,U028400, U020800**

47 22 17 2067722/1 August 26, 2022.

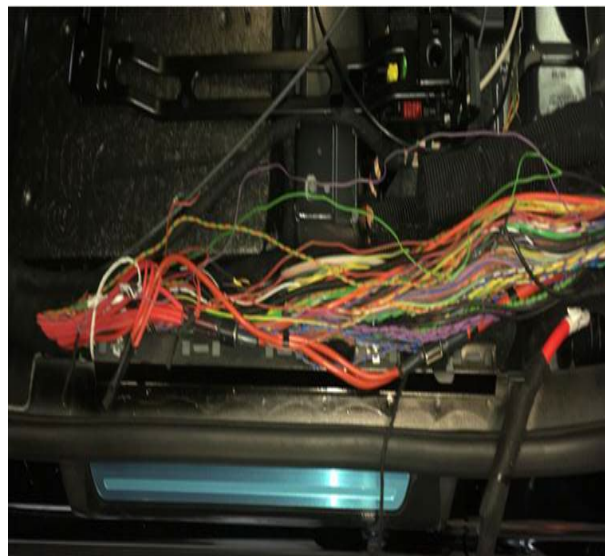
Figure 2: Driver side door sill area, open harness to expose splice points.

2. Repair the splice points.

- a. **All** splice points in this area must be serviced with VAS 1978 B, ensuring that they are watertight.

Non-oxidized splice points: Seal the splice points using shrinking end caps.

Oxidized splice points: Service with VAS 1978 B. Ensure that repaired splice points are watertight.

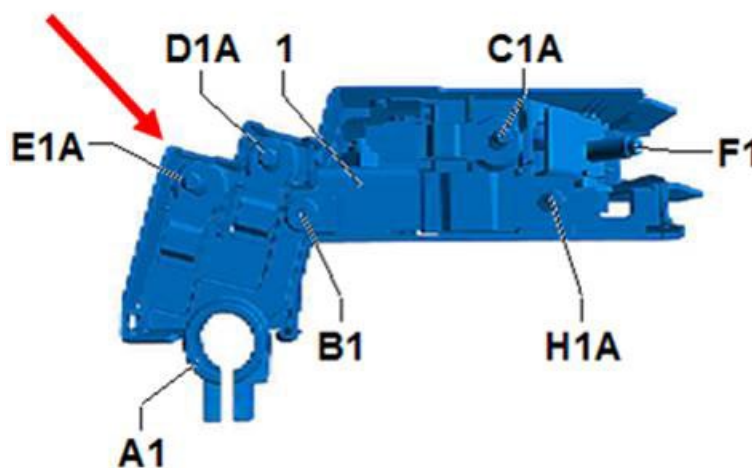
Figure 3: Power supply location at the battery.

- a. Test fit the repair cable in the vehicle.
- b. Disconnect the existing cable at E1A, and bolt the repair cable to the power supply terminal at the battery so that the cable end makes flat contact with the E1A terminal (Figure 3).

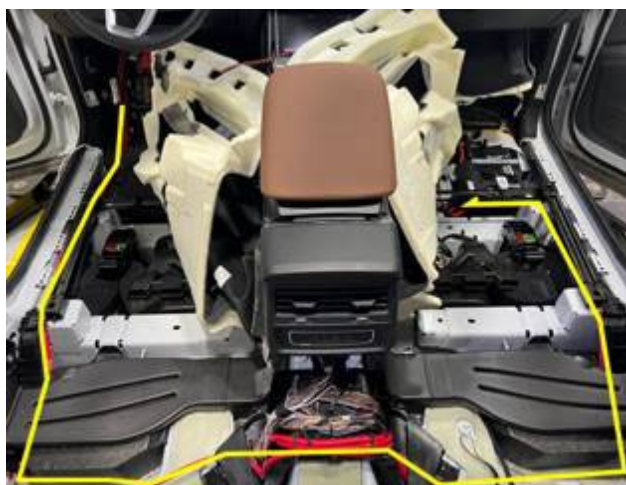
Figure 4: Terminal 30 cable repair routing.

- c. Route the repair cable along the factory routing path from the battery to the LF fuse block as indicated by the yellow line (Figure 4).
- d. Ensure sufficient slack and positioning is obtained along the entire routing path.

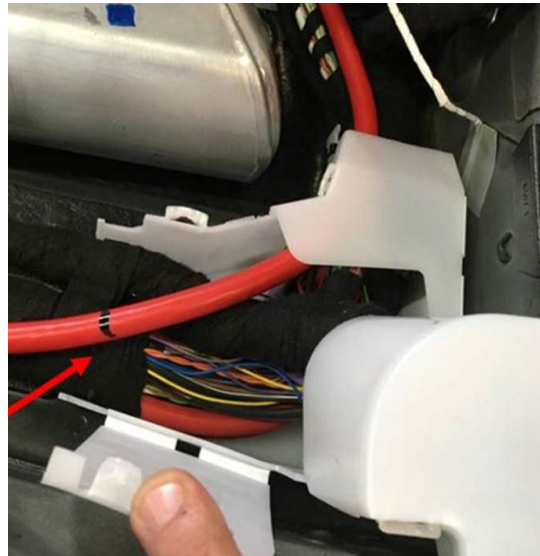
Figure 5: The location is marked as indicated by the red arrow.

- e. Mark the location on the repair cable just after the cable duct on the rear passenger side (Figure 5).
- f. This mark will be used in the next step as the indicator from the point to start wrapping the repair cable.

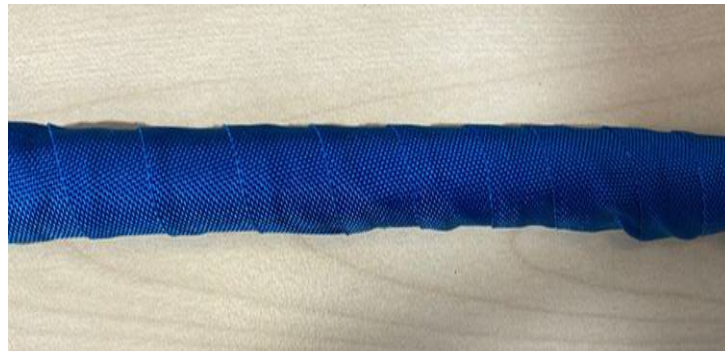
Figure 6: Cable wrapping for N 107 292 04 (blue).

- g. Remove the repair cable from the vehicle and wrap it with textile tape **N 107 292 04** (blue) between power distributor E1A at the battery to the marked location from the last step (Figure 6).

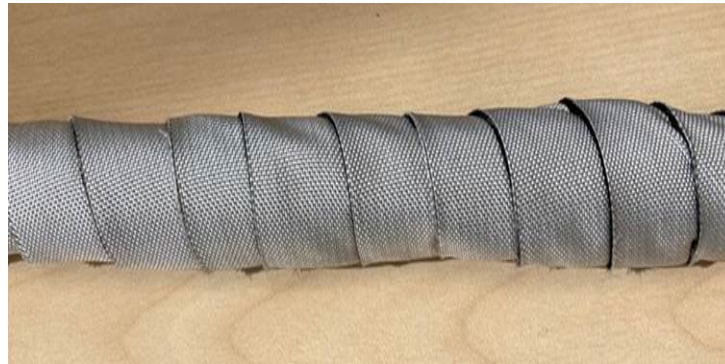
Figure 7: Cable wrapping for N 107 516 03 Gray.

- h. Next, wrap the same section of the repair cable again with textile tape **N 107 516 03** (gray) (Figure 7).

It is very important that the wrappings overlap by 50%. This wrapping is needed for crash requirements.

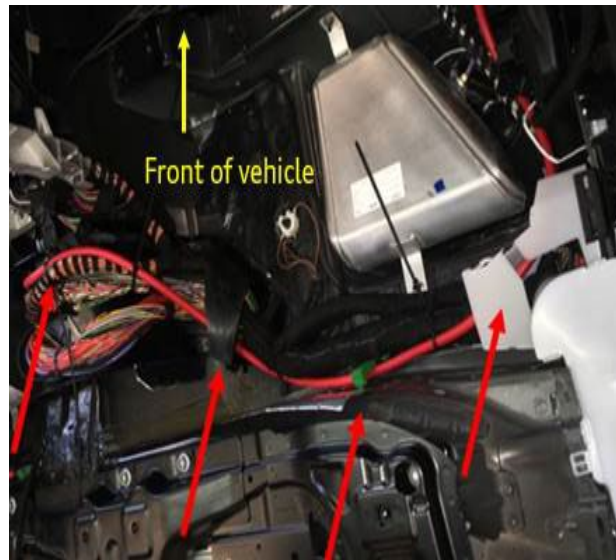
Figure 8: Routing path passenger side. The lower portion of the photo is where the sea bottom mounts.

- b. Route the repair cable into the wiring ducts on the rear passenger side (Figure 8) and the rear driver side (Figure 9).

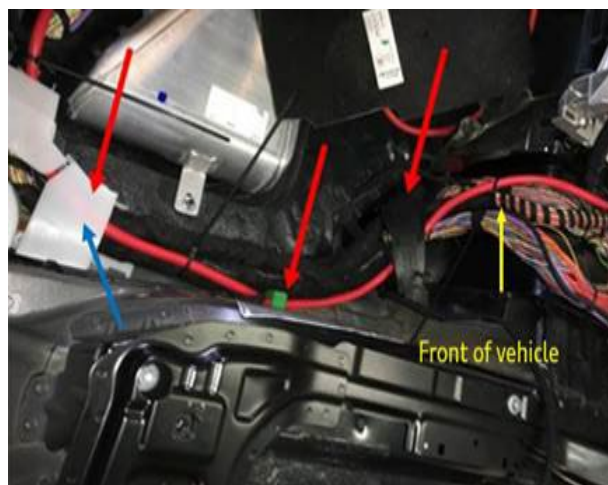
Figure 9: Routing path driver side. The lower portion of the photo is where the seat bottom mounts.

- c. Wrap the repair cable from the duct at the rear drive side (Figure 9) all the way to the last junction point of the repair cable nearest the fuse box.

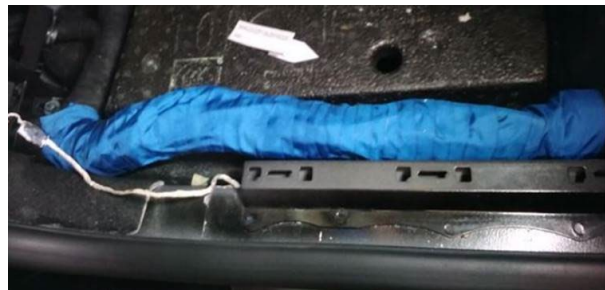
Figure 10: Main wiring harness wrapped with blue textile tape.

- a. The original supply cable does not need to be fully removed from the interior wiring harness.
 - Once disconnected, cut the original cable end off at the E1A connection point at the battery. Seal the end with textile tape **N 107 290 02** and wrap the remaining wire securely onto the interior wiring harness
 - Cut the original power supply wires back in the area of the driver's door sill, ensuring sufficient working space. Seal ends which are cut off with textile tape **N 109 290 02**.
- b. Wrap the entire main wiring harness (including repair cable) between the A and B pillars both on the driver and passenger sides. First wrap with blue textile tape **N 107 292 04** (Figure 10).

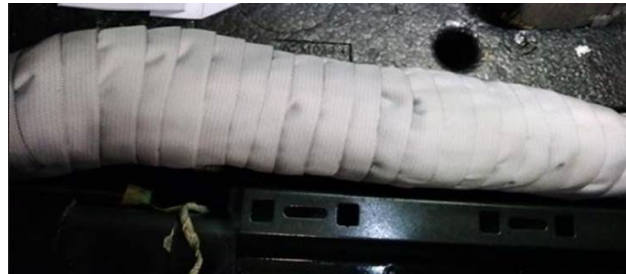
Figure 11: Gray textile tape covering the already wrapped main wiring harness.

- c. Then rewrap with gray textile tape **N 107 516 03** (Figure 11).
