Technical Service Bulletin

97 Q8 Various warnings or functions inoperative, corroded splice points in driver sill. DTC: U150600,U028400, U020800

97 22 86 2067785/2 August 29, 2022. Supersedes Technical Service Bulletin Group 97 number 22-85 dated August 26, 2022, for reasons listed below.

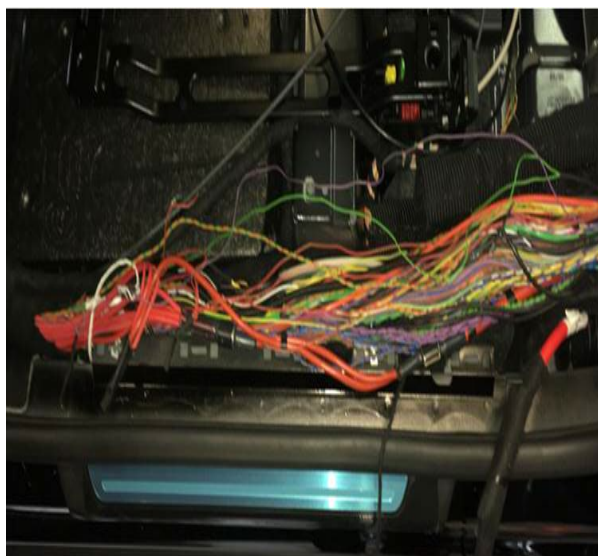
Figure 2: Driver side door sill area, open harness to expose splice points.

- a. De-energize the vehicle before beginning repair.
- b. Carefully open the harness tape of the main vehicle harness located in the area between the A-Pillar and the B-Pillar on the driver's side (Figure 2).

- a. All splice points in this area must be serviced with VAS 1978 B, ensuring that they are watertight.

Oxidized splice points: Service with VAS 1978 B. Ensure that repaired splice points are watertight.

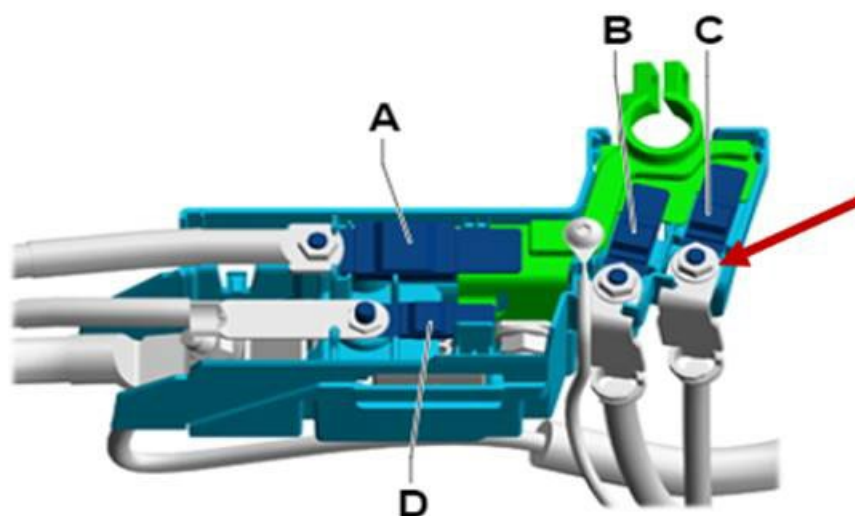
Figure 3: Power supply location at the battery; "C" indicated with the red arrow.

- a. Test fit the repair cable in the vehicle.
- b. Disconnect the existing cable at **C**, and bolt the repair cable to the power supply terminal at the battery so that the cable end makes flat contact with the **C** terminal (Figure 3).

- a. The original supply cable does not need to be fully removed from the interior wiring harness.
 - Once disconnected, cut the original cable end off at the **C** connection (Figure 3) point at the battery. Seal the end with textile tape **N 107 290 02** and wrap the remaining wire securely onto the interior wiring harness
 - Cut the original power supply wires back in the area of the driver's door sill, ensuring sufficient working space. Seal ends which are cut off with textile tape **N 109 290 02**.

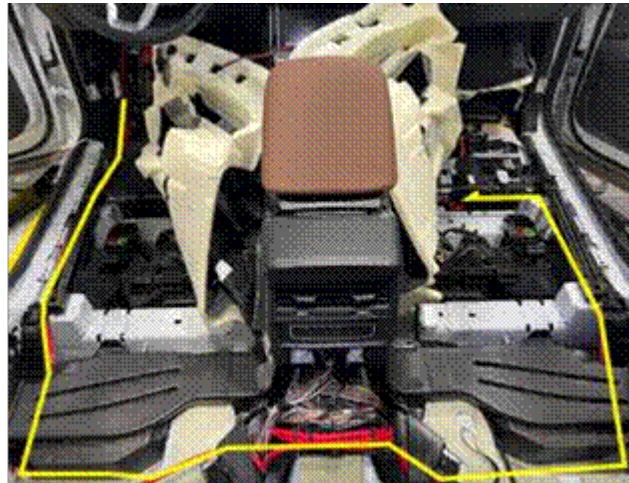
Figure 4: Terminal 30 cable repair routing.

- c. Route the repair cable along the factory routing path from the battery to the LF fuse block as indicated by the yellow line (Figure 4).
- d. Ensure sufficient slack and positioning is obtained along the entire routing path.

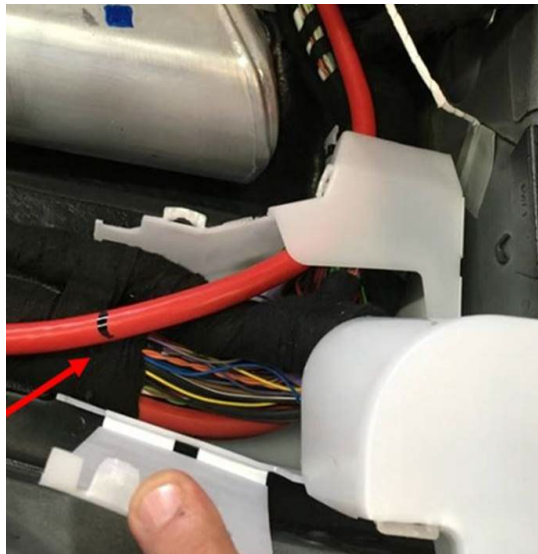
Figure 5: The location is marked as indicated by the red arrow.

- e. Mark the location on the repair cable just after the cable duct on the rear passenger side (Figure 5).
- f. This mark will be used in the next step as the indicator from the point to start wrapping the repair cable.

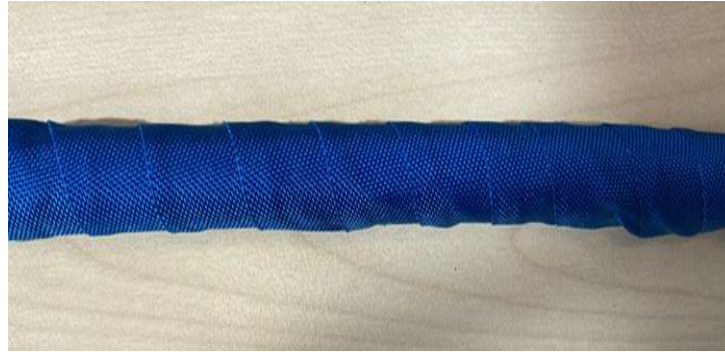
Figure 6: Cable wrapping for N 107 292 04 (blue).

- g. Remove the repair cable from the vehicle and wrap it with textile tape **N 107 292 04** (blue) between power distributor **C** at the battery to the marked location from the last step (Figure 6).

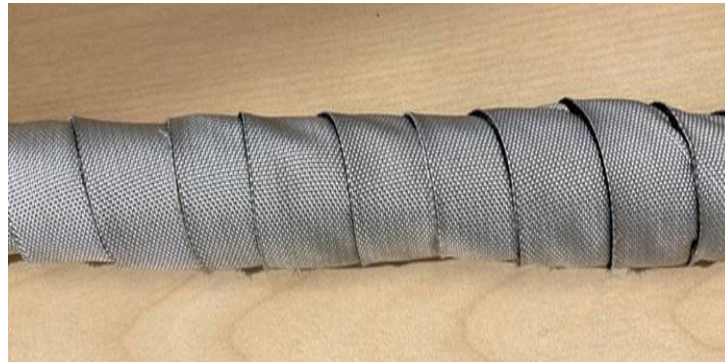
Figure 7: Cable wrapping for N 107 516 03 Gray.

- h. Next, wrap the same section of the repair cable again with textile tape **N 107 516 03** (gray) (Figure 7). It is very important that the wrappings overlap by 50%. This wrapping is needed for crash requirements.

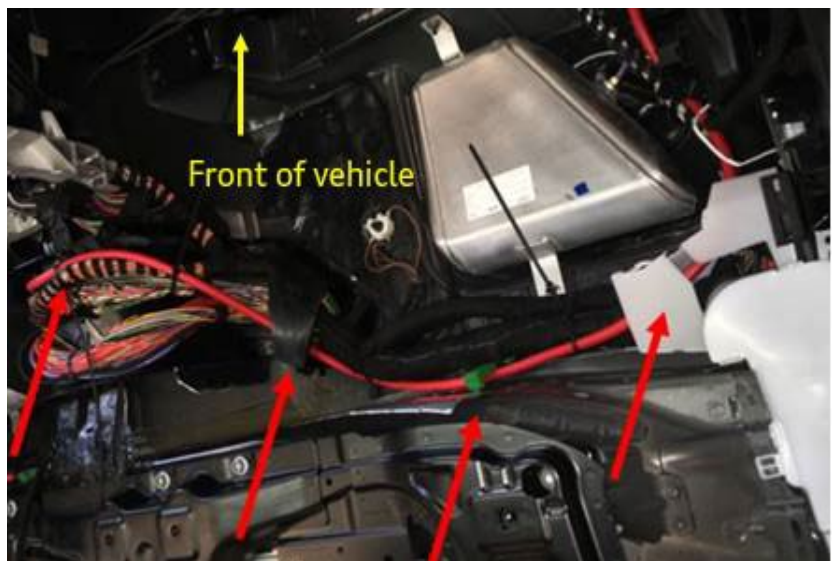
Figure 8: Routing path passenger side. The lower portion of the photo is where the sea bottom mounts.

- b. Route the repair cable into the wiring ducts on the rear passenger side (Figure 8) and the rear driver side (Figure 9).

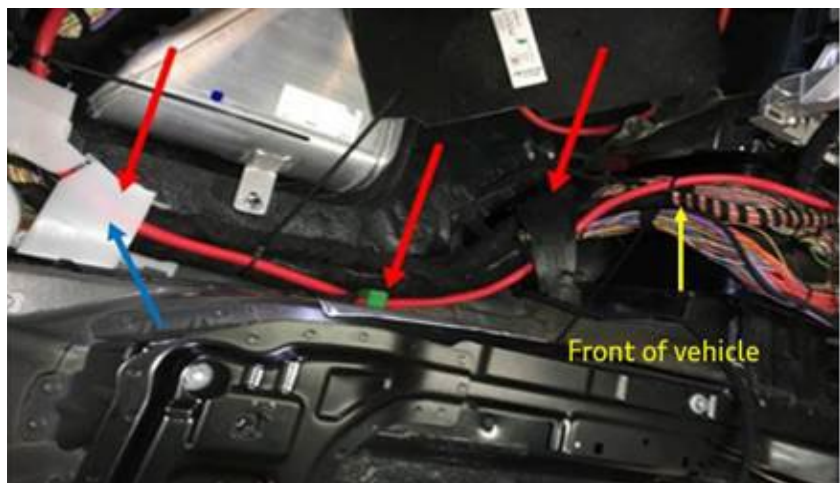
Figure 9: Routing path driver side. The lower portion of the photo is where the seat bottom mounts.

- c. Wrap the repair cable from the duct at the rear drive side (Figure 9) all the way to the last junction point of the repair cable nearest the fuse box.

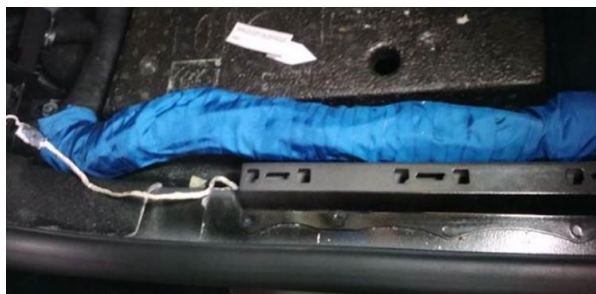
Figure 10: Main wiring harness wrapped with blue textile tape.

- b. Wrap the entire main wiring harness (including repair cable) between the A and B pillars both on the driver and passenger sides. First wrap with blue textile tape N 107 292 04 (Figure 10).

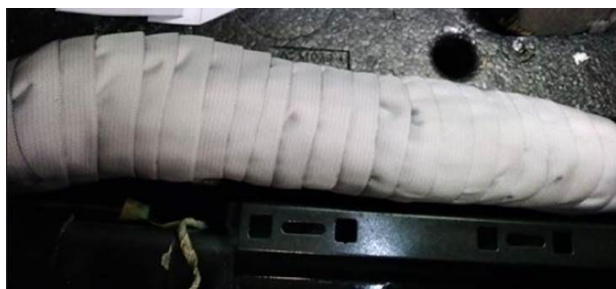
Figure 11: Gray textile tape covering the already wrapped main wiring harness.

- c. Then rewrap with gray textile tape N 107 516 03 (Figure 11).
