| REFERENCE: | Nova Bus Manuals |
| SECTION: | 12: Interior Furnishing |
| RS N°: | MQR 7621-2414 |

| SUBJECT: | Lexan panels cracking at mounting holes. |

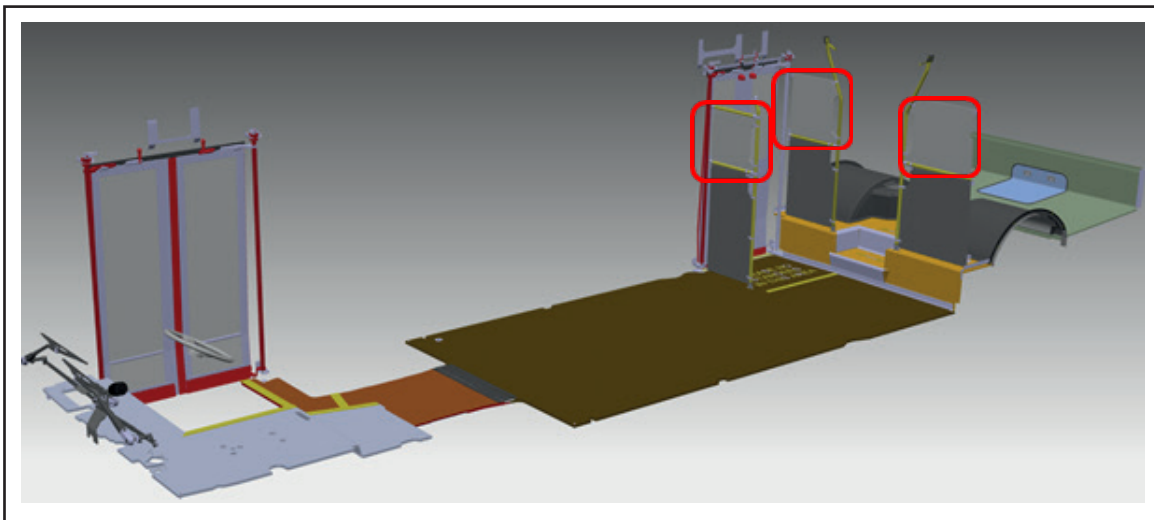
Figure 1 - Location of Grommets inside the bus

- 1.1. Park the vehicle on an even surface with the transmission on neutral.
- 1.2. Apply the parking brake and set the master control switch to the **stop** position.
- 1.3. Set the battery disconnect switch in the battery compartment to the **off** position
- 1.4. Locate grommets to replace inside the bus (see figure 1).

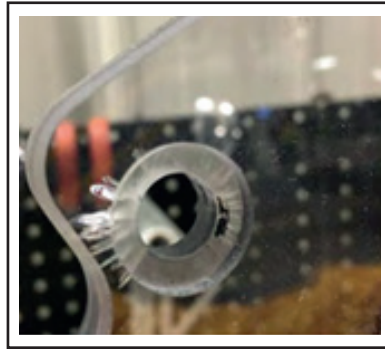
- 1.5. Inspect the Lexan panels for cracking around the corners where the brackets are mounted to the Lexan panels, document road number and panel to be changed if cracks are apparent (see figure 2).

Figure 2 - Cracks on the Lexan Panel

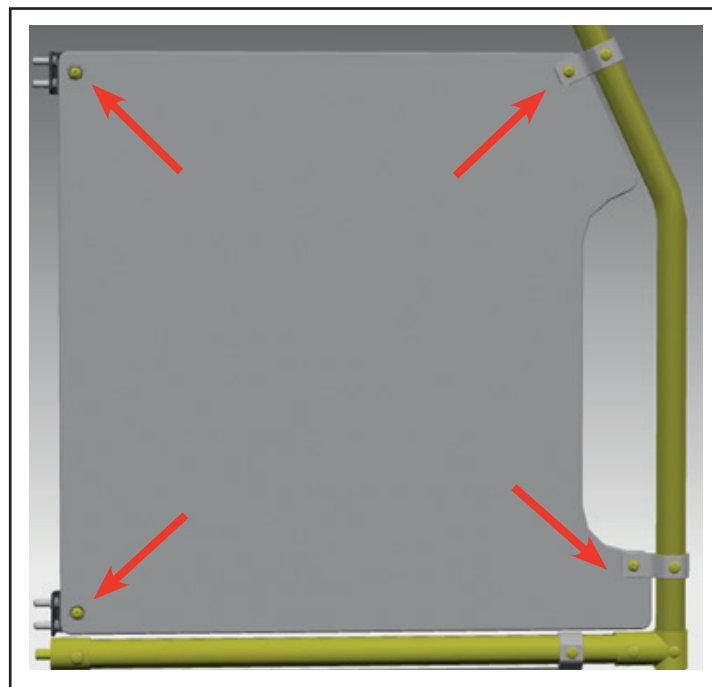
Figure 3 - Removal of Old grommet on the Lexan Panel

- 1.6. Remove the old grommets in the 4 corners of each Lexan panel (see figure 3).

Once grommet has been removed, clean the area using alcohol, be sure to remove all residual material from the holes on the Lexan panels, a soft bristle brush can be used to help get the remaining residue.

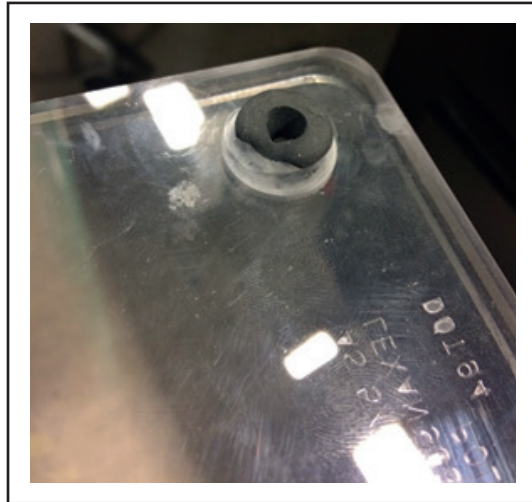
Figure 4 - Installation of New grommet on the Lexan Panel

- 1.7. Insert the new grommet P/N N67402 (see figure 4).

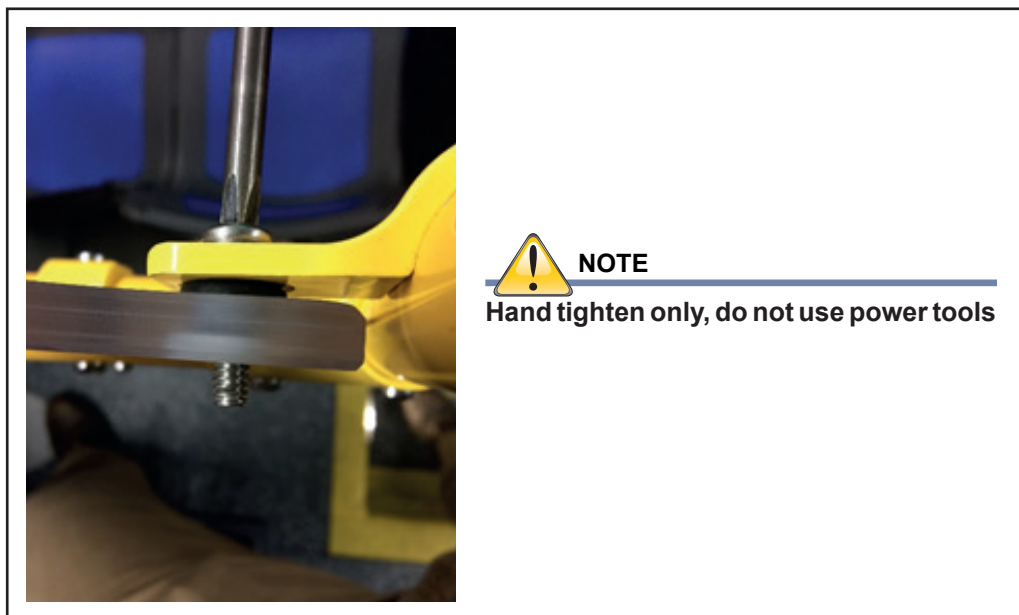
Figure 5 - Installation of Screw and Washer

- 1.8. Install new screw P/N N15548, reuse existing Washers and Nut (see figure 5).
