# TECHNICAL SERVICE BULLETIN

Classification: AN21-013A	Reference: NTB21-107A	Date: August 19, 2022
------------------------------	--------------------------	--------------------------

## SOFTWARE UPDATE FOR INFOTAINMENT ISSUES

**APPLIED VEHICLES:** 2019-2020 Maxima (A36)

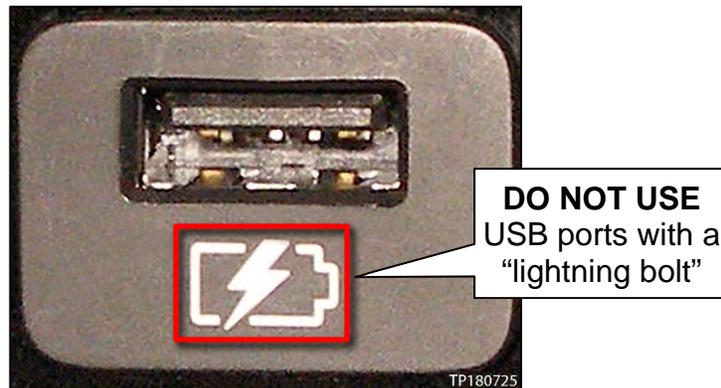
Figure 12

Do not insert the USB drive into a charging port (Figure 12). If used, the update-software and/or USB drive may become damaged. Only insert the USB drive in a USB media port.

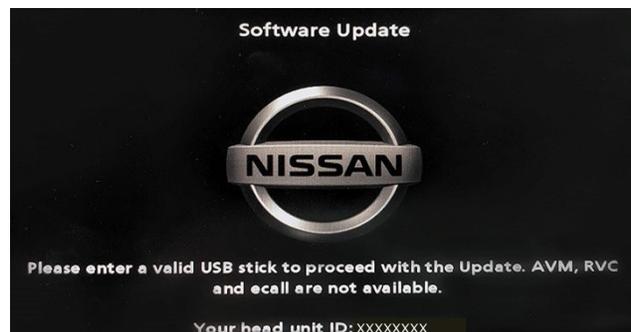
- The screen in Figure 14 may briefly appear. **Do not remove the USB drive.** The audio system will detect the USB drive and continue the update.
