SERVICE BULLETIN

Classification: BT22-007	Reference: NTB22-068	Date: August 2, 2022
-----------------------------	-------------------------	-------------------------

WATER LEAKING FROM REAR WIPER ARM PIVOT SEAL

APPLIED VEHICLES: 2021-2022 Rogue (T33)

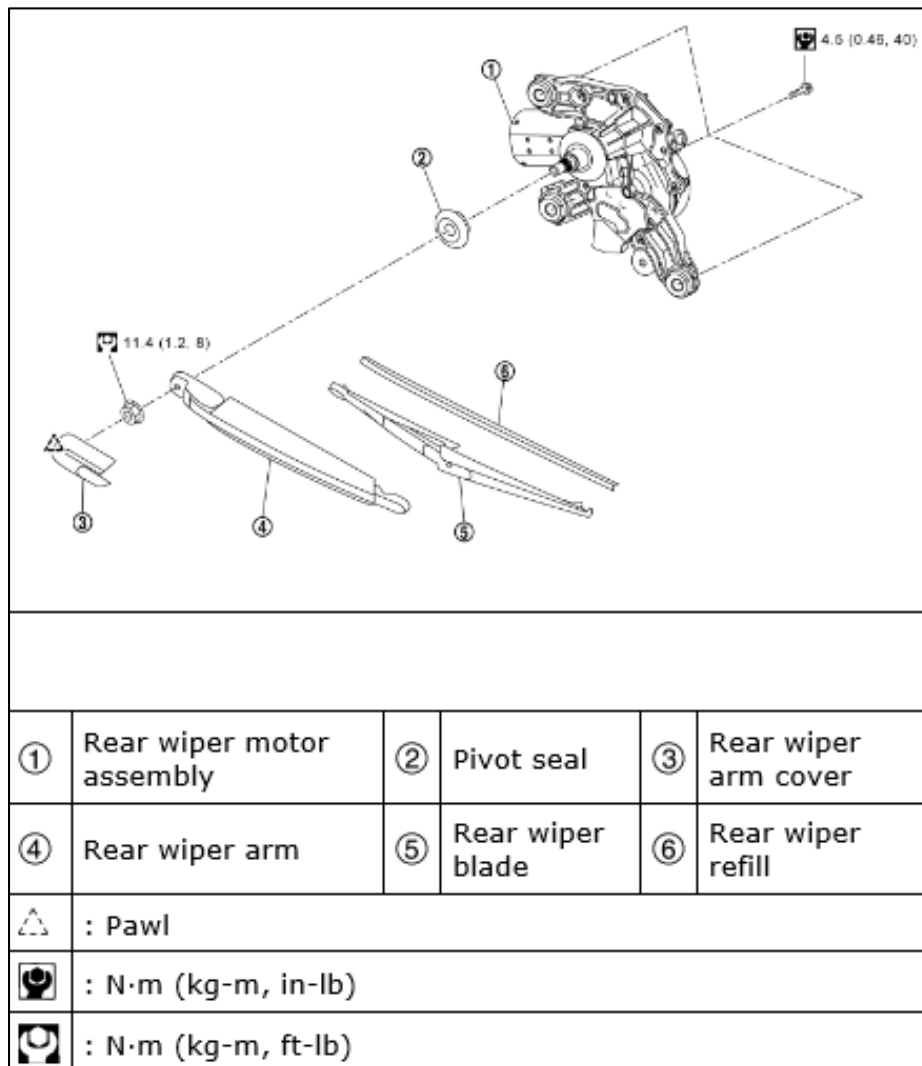
Figure 1

Water is found to be leaking around the rear window wiper arm pivot seal after performing a water soak test.

1. Replace the rear wiper arm pivot seal (#2 in Figure 1).
 - Refer to the ESM: **DRIVER CONTROLS > WIPER & WASHER > REMOVAL AND INSTALLATION > REAR WIPER > WIPER MOTOR**
