TECHNICAL SERVICE BULLETIN

Classification: BT22-017	Reference: NTB22-075	Date: August 24, 2022
-----------------------------	-------------------------	--------------------------

DRIVER'S POWER SEAT RECLINES UNINTENTIONALLY

APPLIED VEHICLES: 2022-2023 Frontier (D41)

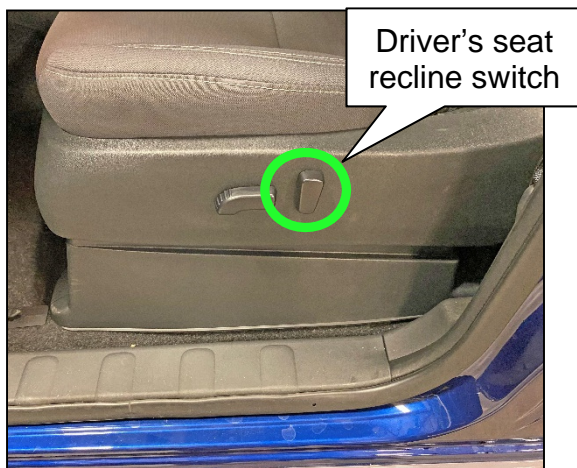
Figure 1

The driver's seat recline switch (Figure 1) can be bumped when exiting/entering the vehicle (Figure 2), resulting in unintentional recline of the seat upper.

Do not replace the side finisher/switch unless visible damage to the seat switch is present.
